# Lenovo ThinkCentre A70z Backlight Cable Replacement

The ThinkCentre A70z Monitor lamp turns off so can't see display without a light to verify LCD screen is working.

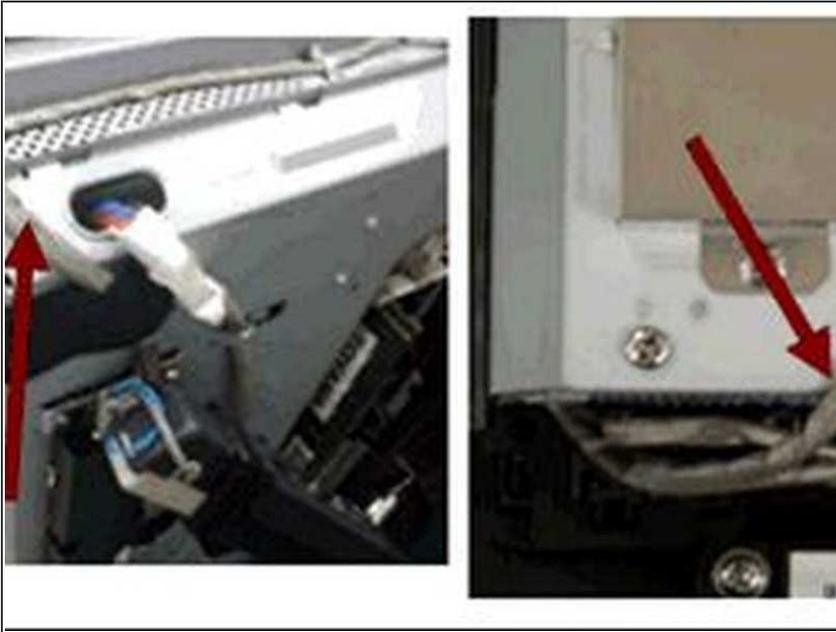
## Step 1 — Remove Conductive Tape from Backlight Cable

The issue is caused by the conductive tape wrapped around the backlight cable as seen below.

The issue has a low failure rate with the woven type of conductive tape. However, has a high failure rate with an aluminum foil type of conductive tape.

LG panel mentioned, "do not attach a conducting tape to lamp connecting wire directly. If the lamp connecting wire attach to a conducting tape. LCD module will have a risk for low luminance.

- Remove conductive tape wrapped around the backlight cable as below seen below.
- The issue has a low failure rate with the woven type of conductive tape. However, has a high failure rate with an aluminum foil type of conductive tape.

I removed the conductive tape wrapped around the backlight as noted and now the computer is working great again other than a login issue that will be corrected with a Windows 10 reset or I'm thinking a fresh install of a Linux OS for a multiboot system.
