Philips Wake-Up HF3520 Power supply repair

The IC (chip) inside the lamp seems to die...

Written By: Thomas Widmaier

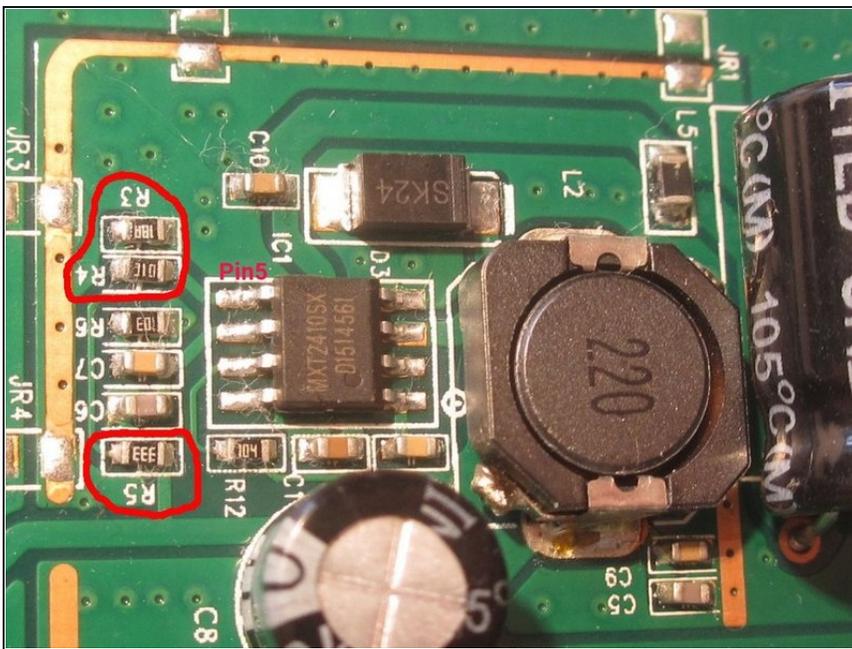
Step 1 — Replace the IC chip

The IC (chip) inside the lamp seems to die slowly resulting in flickering/flashing lamp operation when using the radio. Also, the buttons may become unresponsive.

The problem occurs specifically when the device is cold and/or humid. Heating up the IC makes it work again.

- On the main PCB with the power jack, replace the MXT2410 switchmode regulator IC (SO-8 Package).
- Currently a seller "adeleparts2010" has this chip available (might change in future).

⚠️ The ACT4060 is pin-compatible but can be a problematic choice. It can blow up and damage LEDs, so don't use it.
