Saeco Vienna Sup 018 water tank seal replacement

Replacement of the water tank seal on a Saeco Vienna Sup 018

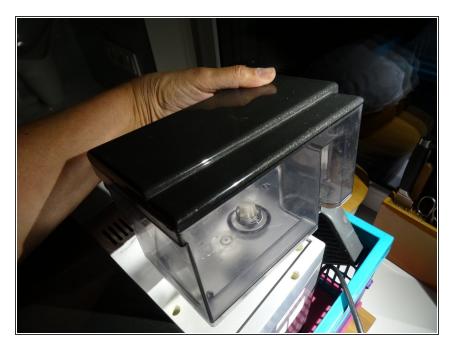
Step 1 — Water tank seal

• Lift the water tank off the machine

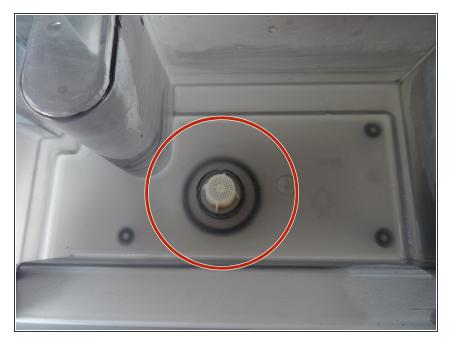
Step 2

With your fingers pull the filter off the water outlet.

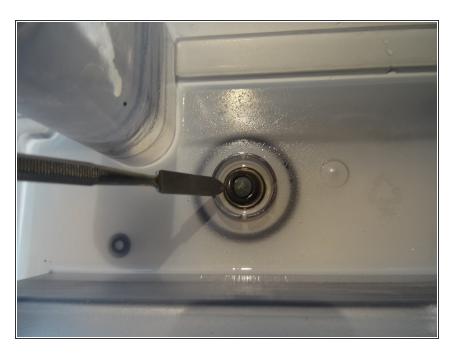
Step 3

With your fingers press the valve stem from the bottom up. Now you can pry off the seal with a spatula tip.

To reassemble your device, follow these instructions in reverse order.
