R52WH74 Motherboard Component Replacement

This model is known to have issues with convergence. The screen will look distorted, almost 3D, and it will look bowed. Replacing the Fuse FL231 as well as the Diode DL231 and the capacitor CL230 should fix this.

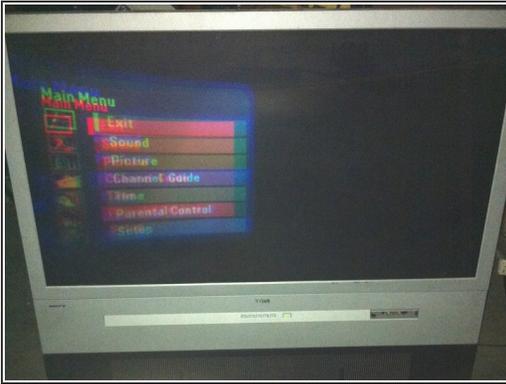
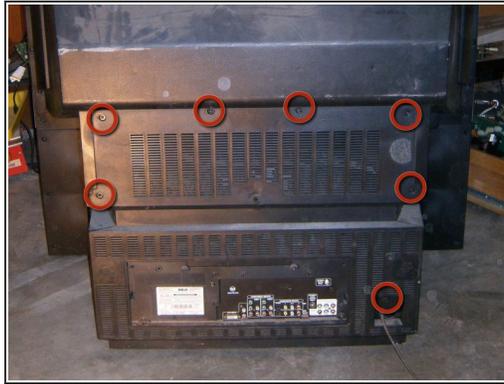
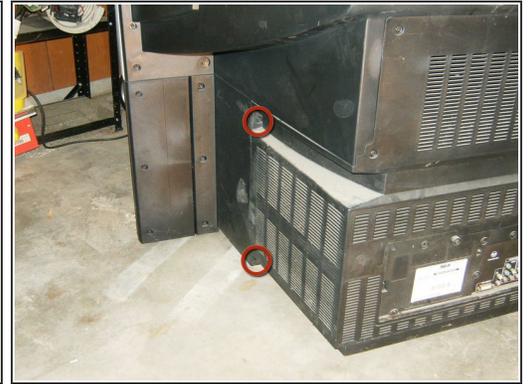
Step 1 — Convergence

- Here is what it looks like when the convergence is off.
- Remove the seven screws from the back.
- Remove the two screws from the left side.

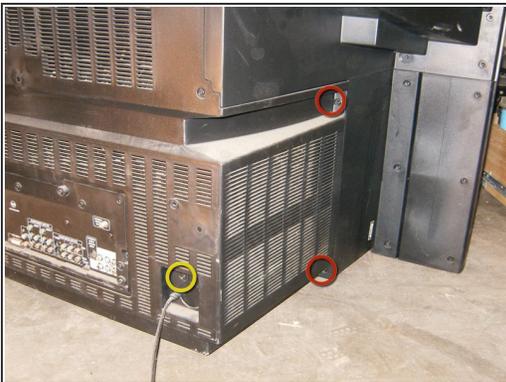
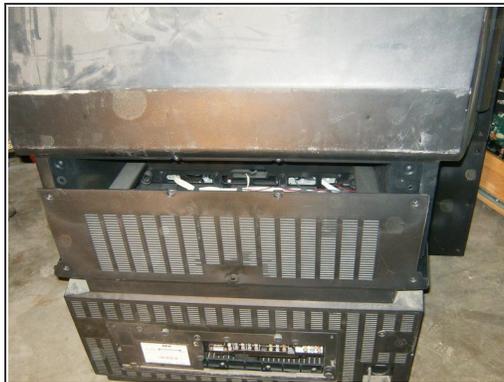
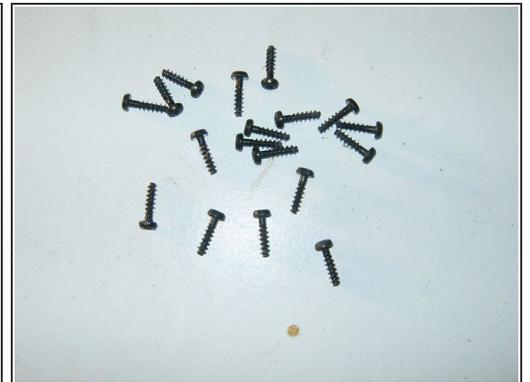
Step 2

- Remove the two screws on the right side.
- Also visible is the screw by the power cable.
- Remove the back of the TV
- All the screws on this TV are the same length, and all are T20.

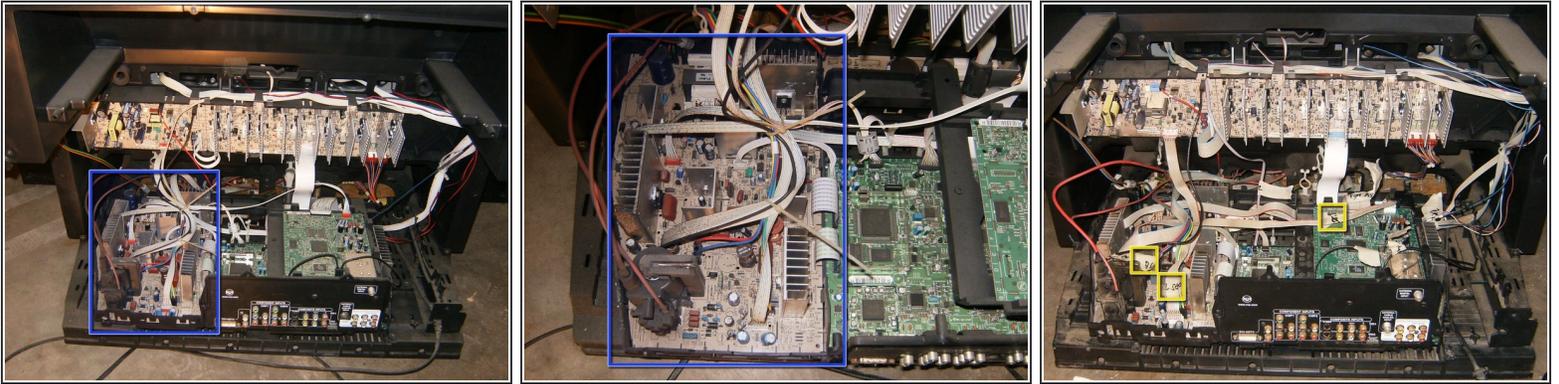
Step 3

- This is the deflection power board part number PSB-260
- Closer look on the the same boards reveals all the connectors (definitely not nice)
- Mark all the cables with a piece of masking tape and there relevant position on the board. This will make assembly easier.

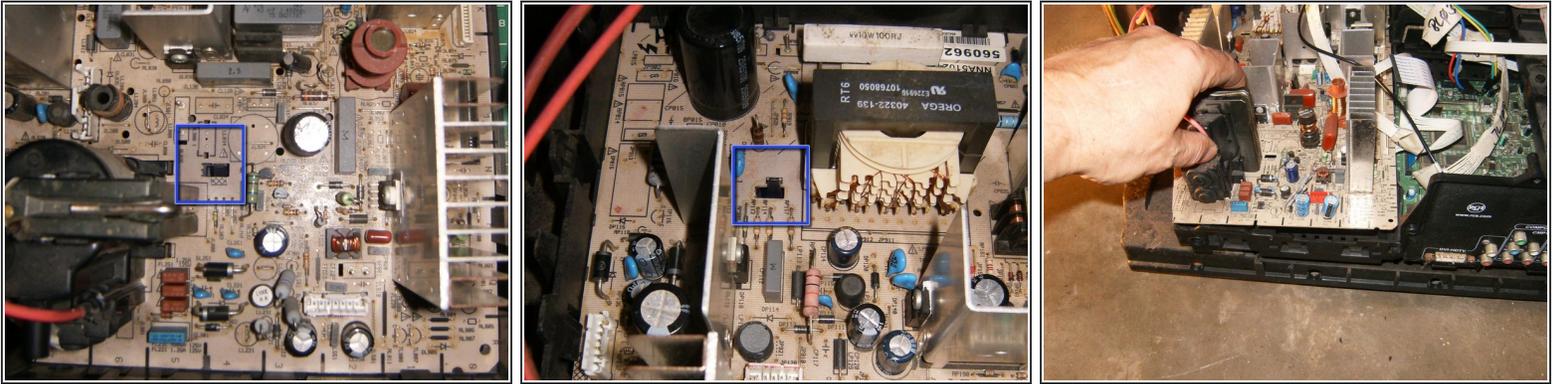
Step 5

- There are two plastic tab on the inside of the board. One on the bottom.
- The other one on the top side.
- Start at the front side of the plastic chassis and squeeze the tab away from the board, at the same time, lift the board in an angled motion out of the chassis.

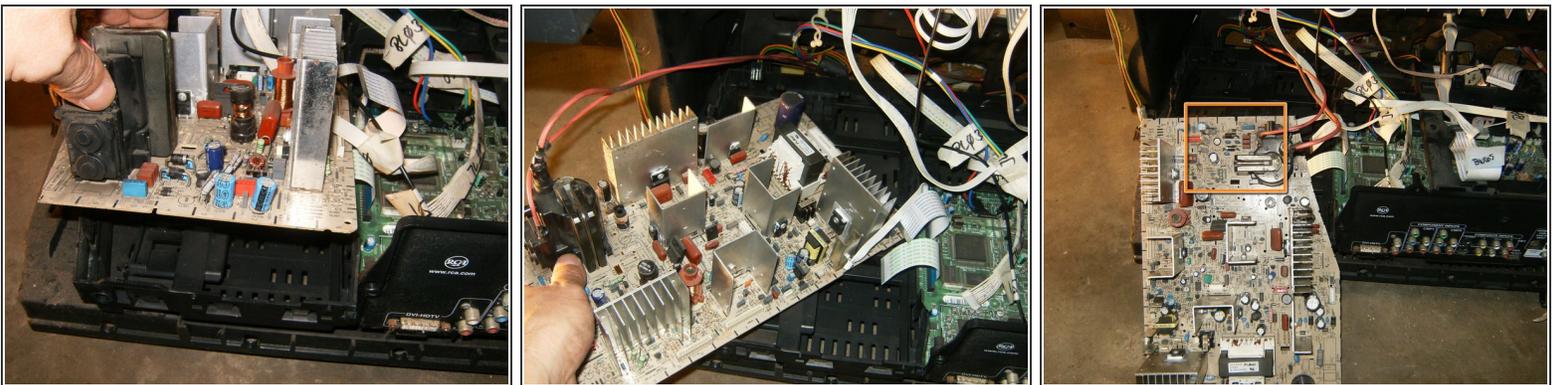
Step 6

- Continue to lift until the last of tabs has been cleared.
- With all the tabs cleared move the board out of the plastic chassis and slightly to the left. There should be enough room with the Fly Back Transformer cables still attached.
- With the board cleared of the chassis, this is the area that contains all the components that are to be replaced.

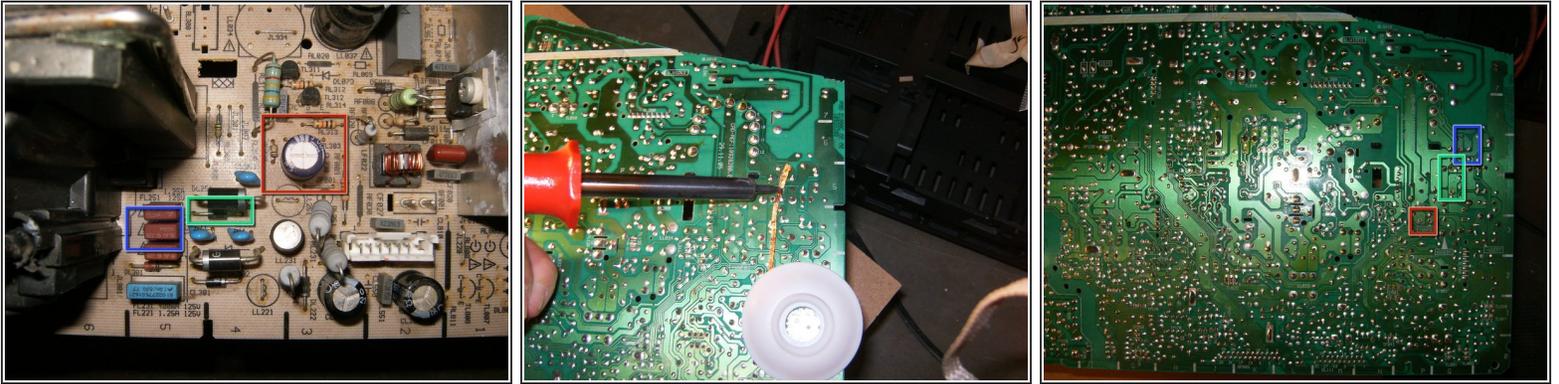
Step 7

- Here are the three components:
 - FL231 125V UL FA LL .400A TE5 fuse
 - DL231 Diode Rectifier 1A 600V
 - CL230 Capacitor 100uF 100V
- Unsolder all three components. Use solder wick and some flux, or a solder sucker.
- View of the solder side with components removed.

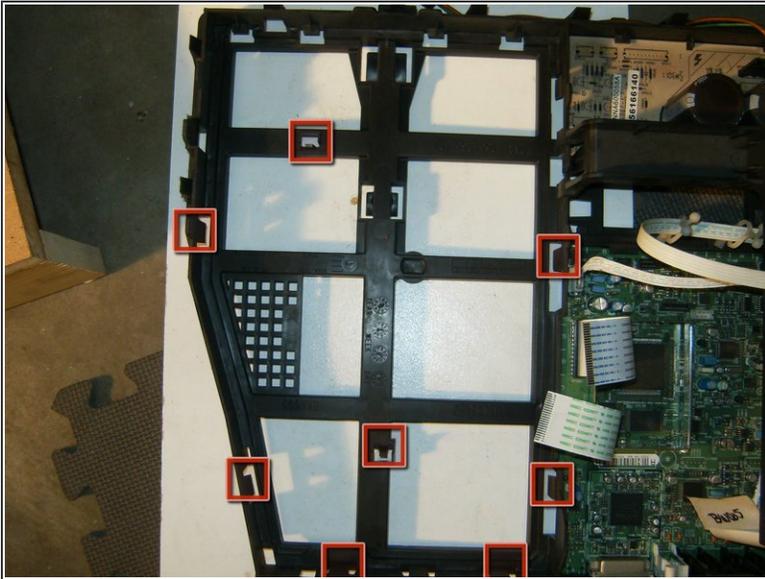
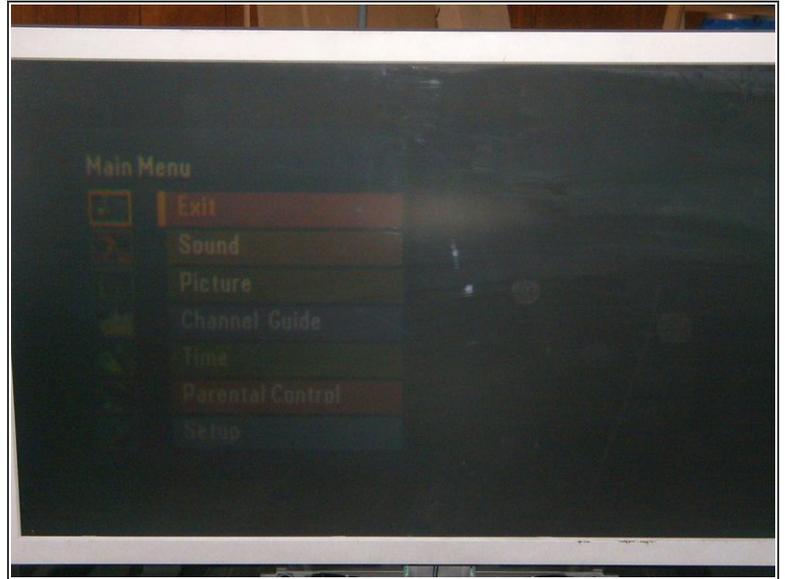
Step 9

- With the components replaced it is time to reassemble the TV. Here is another look at the plastic chassis with all the clips.
- Hopefully your results will be like mine. Perfect convergence. Totals cost for the repair \$1 for parts and \$5 for shipping. Total time about 2 hours.
