Toyota Tundra 2nd generation (2007-2013) Tailgate Handle Replacement

In this guide you will be replacing the tailgate handle. **2007-2013 Toyota Tundra - Tailgate Handle, Textured Black model number (690900C051)** is the part you will be using. Make sure to go slow as these screws are very easy to strip. The broken tailgate handle needs to be replaced because you won't be able to lift it up and down, causing the whole truck bed to be less usable. After this guide you should be able to use your truck bed to its fullest capacity as needed.

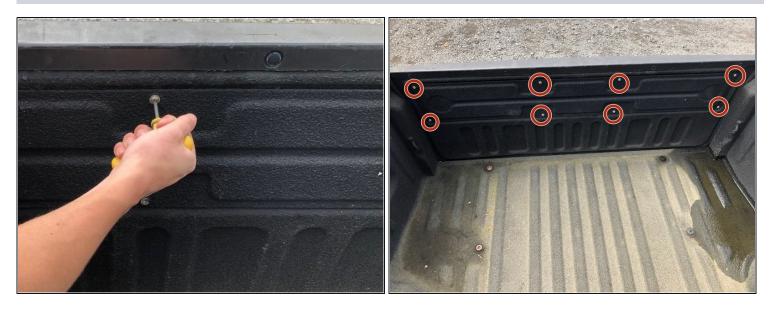
Step 1 — Tailgate Handle

Remove the Torx-head screws (23.2mm) on the inside panel of the tailgate, using the torx T25 screwdriver.

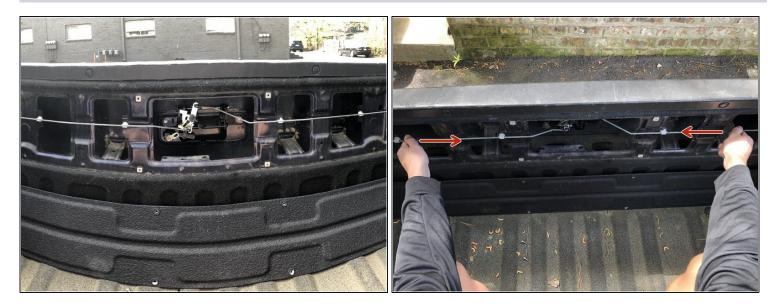
• Pull off the panel and then pull cables inward, causing tailgate to release and go down.

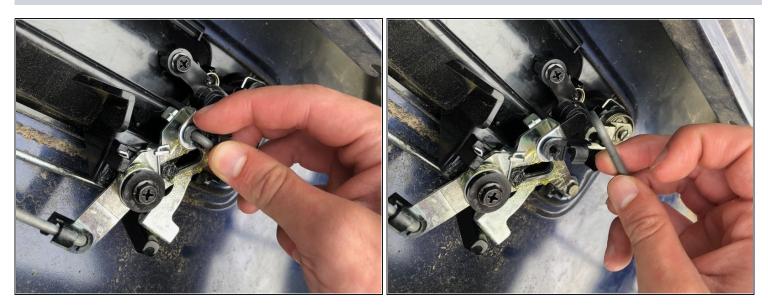
Step 3

• Remove rubber pieces from cable and pull cable from insert.

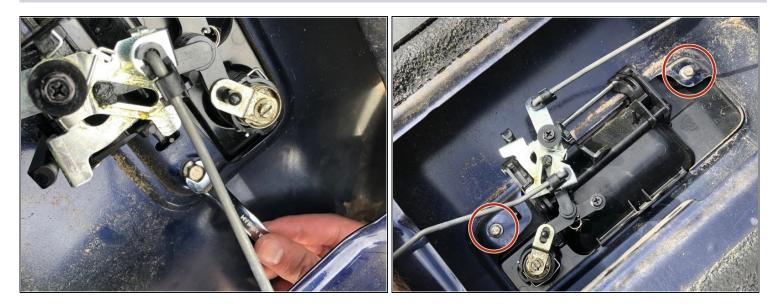
• Use your 5/16th-in. wrench to turn bolt counter clockwise and remove the bolts (18.5mm).

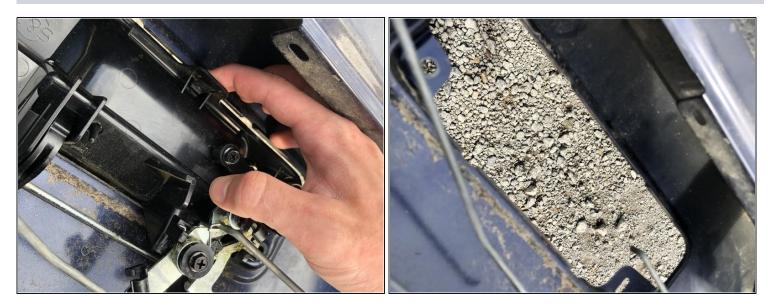
Step 5

• Push in black clip to let handle fall out.

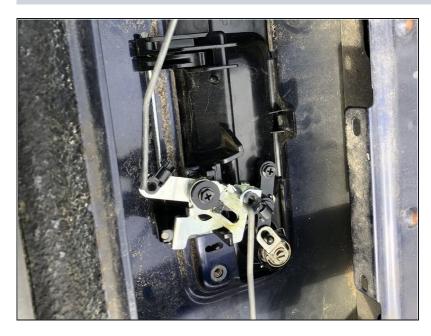
• Put new tailgate handle back in.

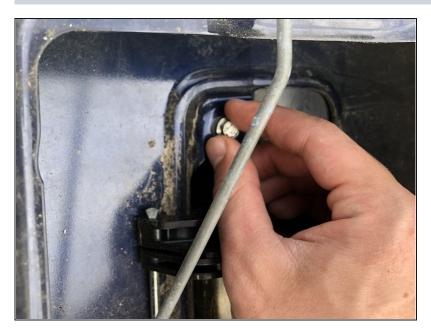
Step 7

• Hand twist in bolts; then tighten with wrench.

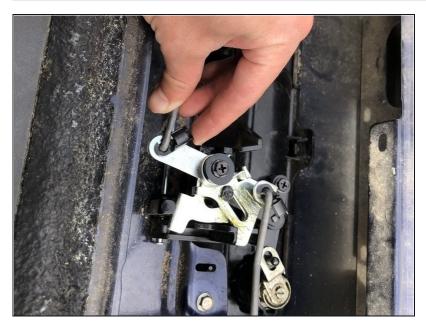
• Insert cable back into socket and press rubber lock onto cable.

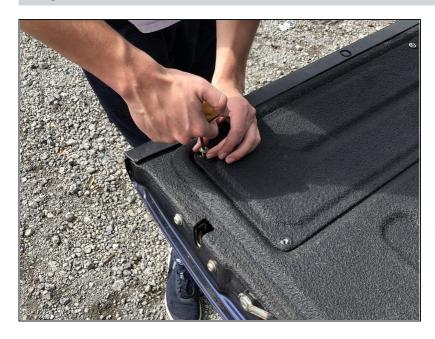
Step 9

Put panel back into place and screw in using your torx -T25 screwdriver.
