RYOBI 404Y Leaf Blower Handle Replacement

This style leaf blower has an extra long handle with can become cracked near its base but can be replaced.

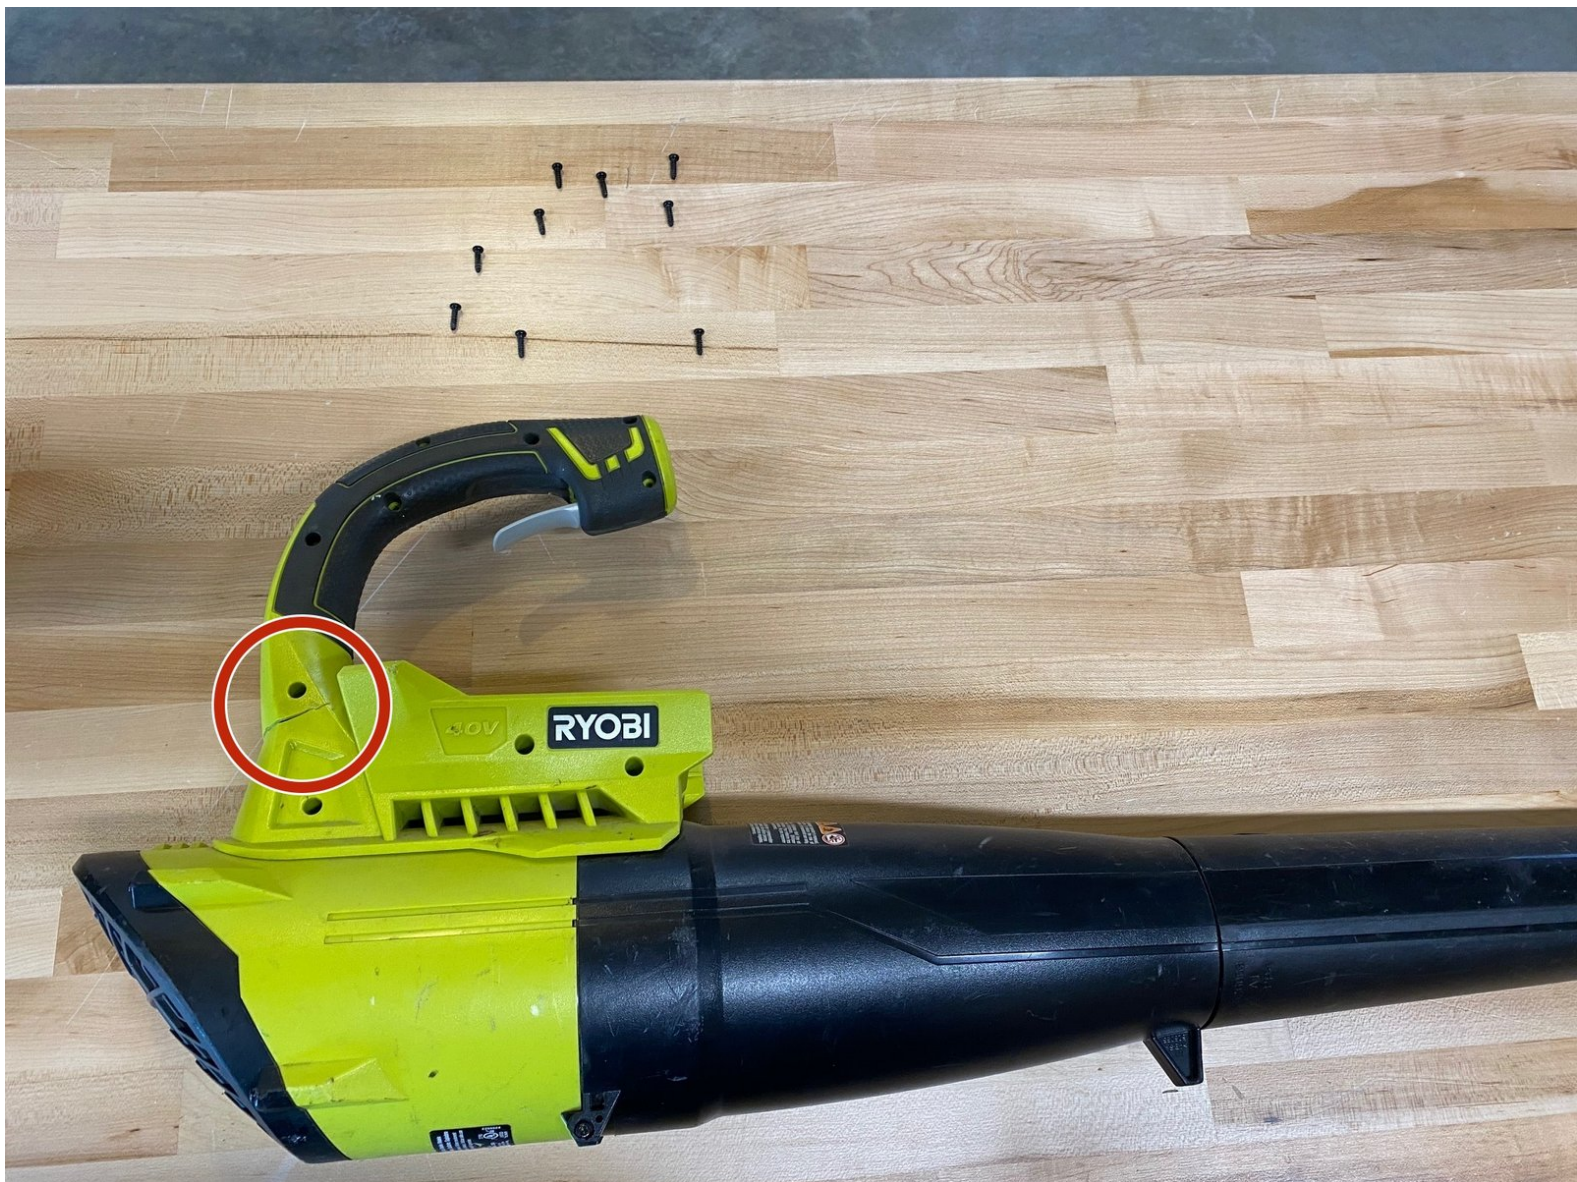
Some hard use and an accidental drop caused the handle on this leaf blower to become cracked right at the base. It can be easily fixed.

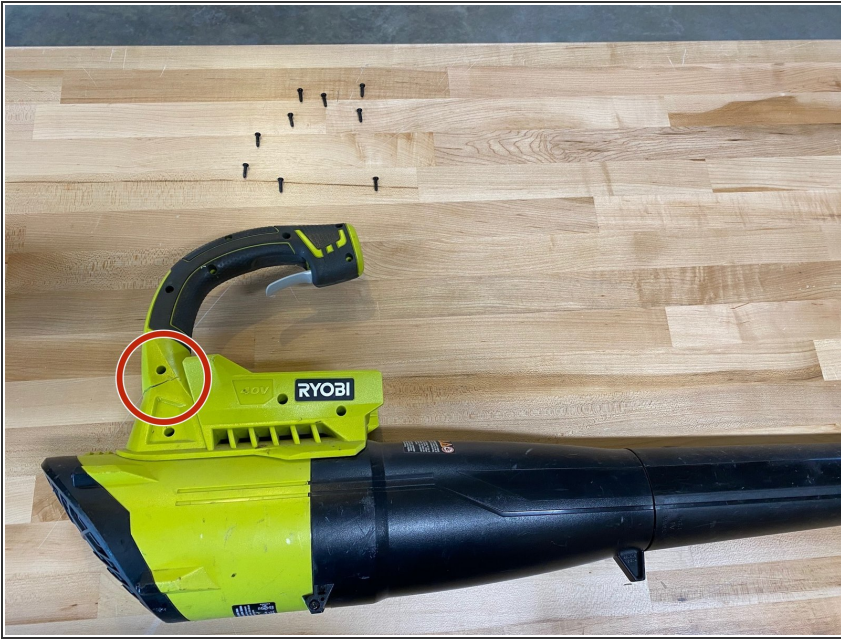
Step 1 — Handle

- Pretty easy fix, can be done in 10-15 minutes.

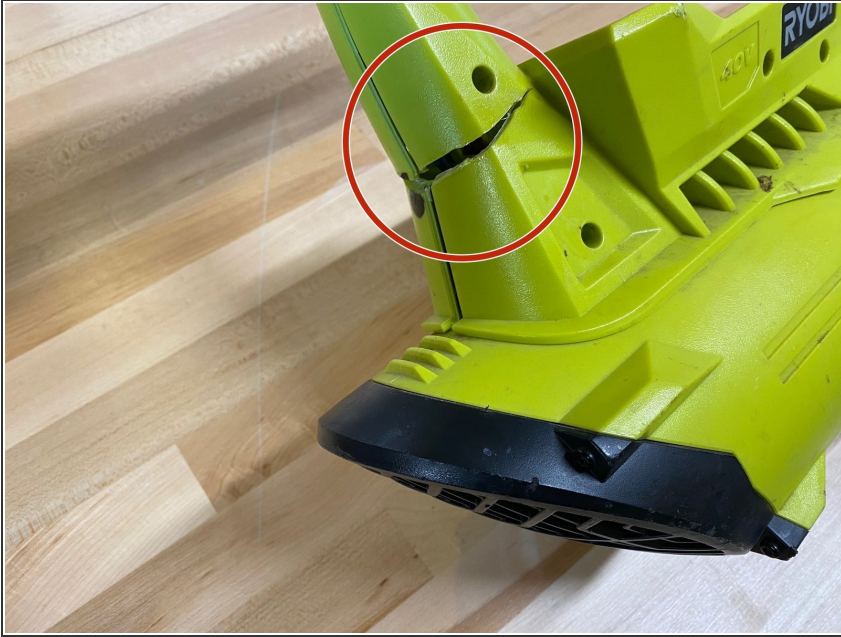
Step 2

- This style of handle can become cracked at the base. In this case it was broken almost completely through and very weak, but it can be replaced. This

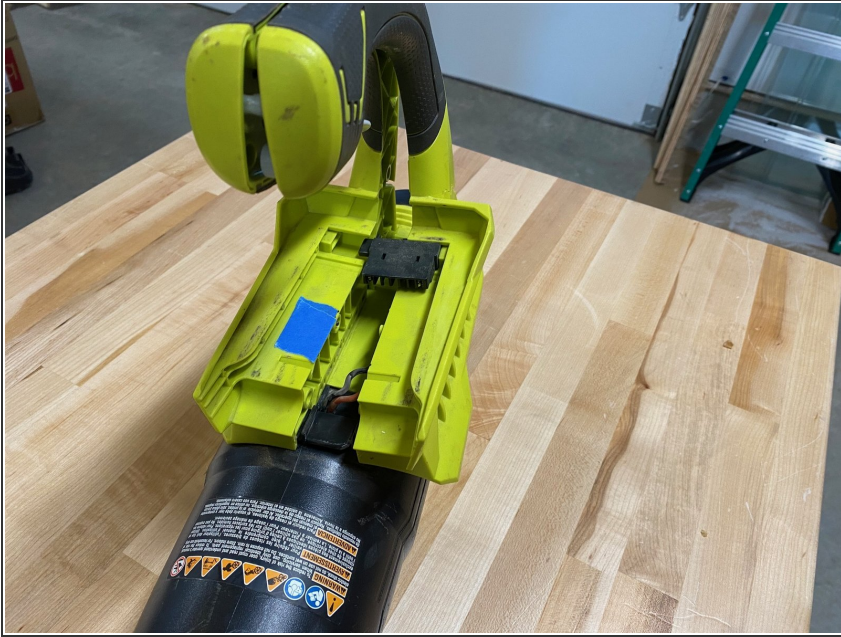
Step 4

- Handle housing is a simple clamshell design.

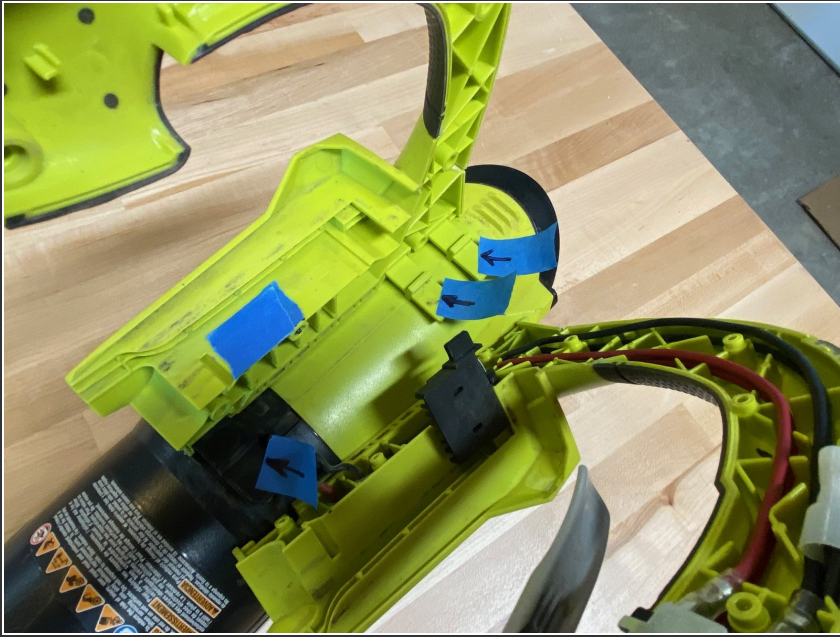
Step 6

- This view shows you the 3 alignment tabs. (see arrows on blue tape in picture) The handle slides onto these tabs. There will be no other clips or tabs.

Slide handle onto the 3 base tabs.

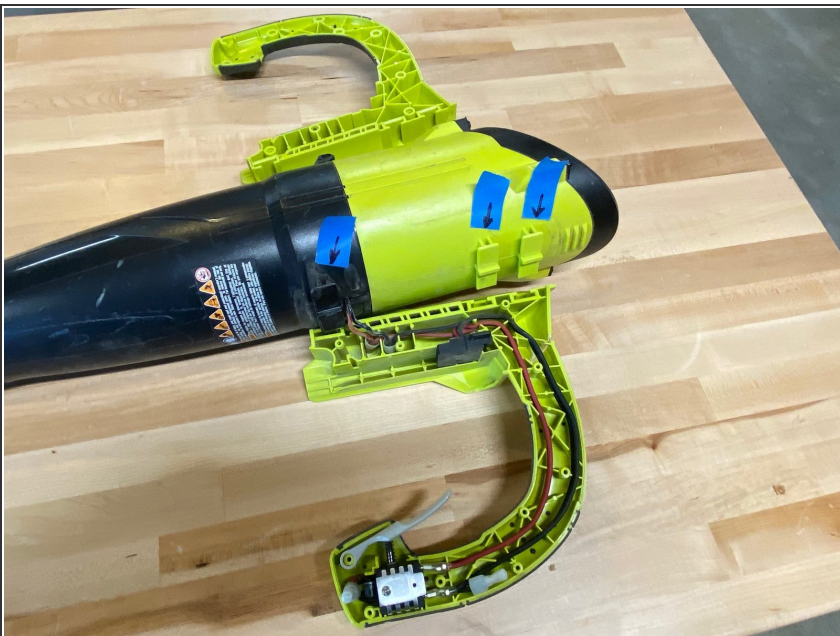
Step 7

- Wire routing is also simple. Wires are pushed into grooves in the handle. Remove wire harness and switch with a gentle tug. Reassemble in reverse order. You will notice that the screw positions have a male/female fit helping with alignment.

Reinstall wire harness into handle.
