Saeco Talea/Odea Brew Unit SBS Valve Replacement

Coffee leaking from the machine might be due to a failed brew unit SBS valve. This repair guide shows how to identify and repair this problem

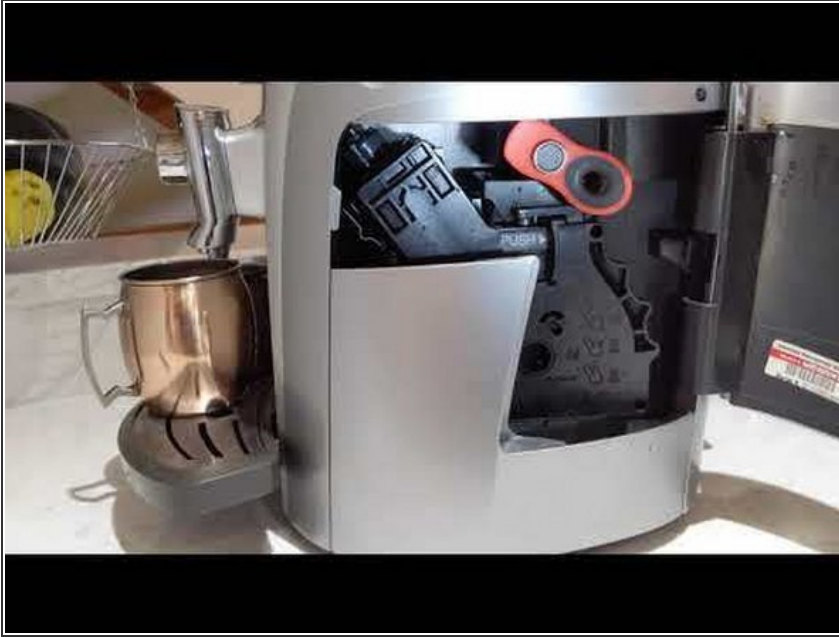
Step 1 — Identify the coffee leak source

- Coffee leak!
- There are several o-rings in the brew unit that could be the source of leaks. I replaced all of those and that didn't fix the problem. After figuring out how to observe the brew unit during operation, I found that the leak was coming from the SBS valve.
- The leak is coming from somewhere in the brew unit, but with the door closed, you can't see it in operation to identify the specific leak location.
- Use a magnet to bypass the door open detector so you can observe the brew unit in operation. (See video - [Saeco Talea Giro brew unit leak diagnosis](#))
 - I used a bag clip with an attached magnet and clipped it onto the sensor.
- Run the brew cycle. You can use the coffee bypass cycle because you don't need to waste your good beans for this test. And, it's easier to clean up if it's just water.
- Look for leaks!

- On my machine, the SBS valve on the upper left of the brew unit was leaking during the brewing process. This valve admits the pressurized water into the brew unit and includes a one-way check valve to keep the pressure in.

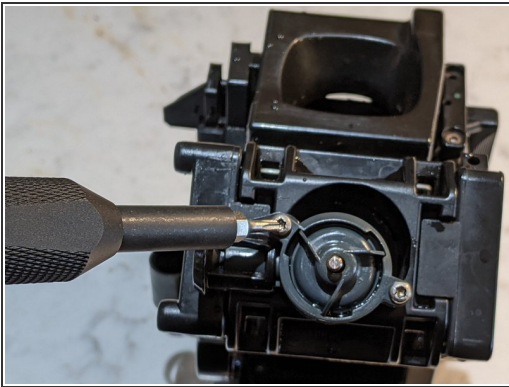
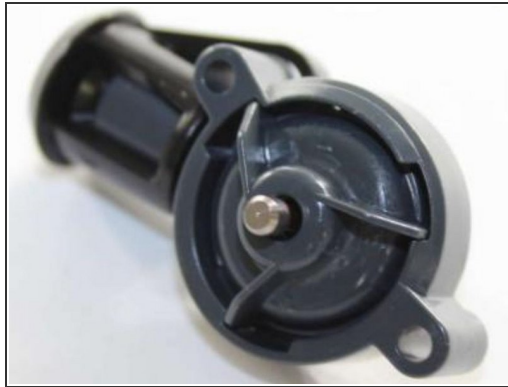
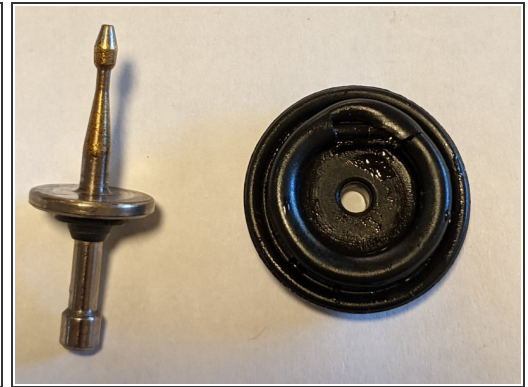
Step 2 — Inspect the SBS valve

- Use a T10 torx screwdriver to remove the SBS valve. It might take a little force to pop it off the brew unit once the screws are removed.
- Remove the top part of the SBS valve (with the 3 "wings") by turning it counter-clockwise. Be careful not to lose the spring!
- Inspect the valve diaphragm. Mine had a split, clearly the source of the coffee leak!
