Keurig B70 Platinum Check Valve Replacement

This guide will show you how to remove and replace the check valve in the Keurig B70 Platinum.

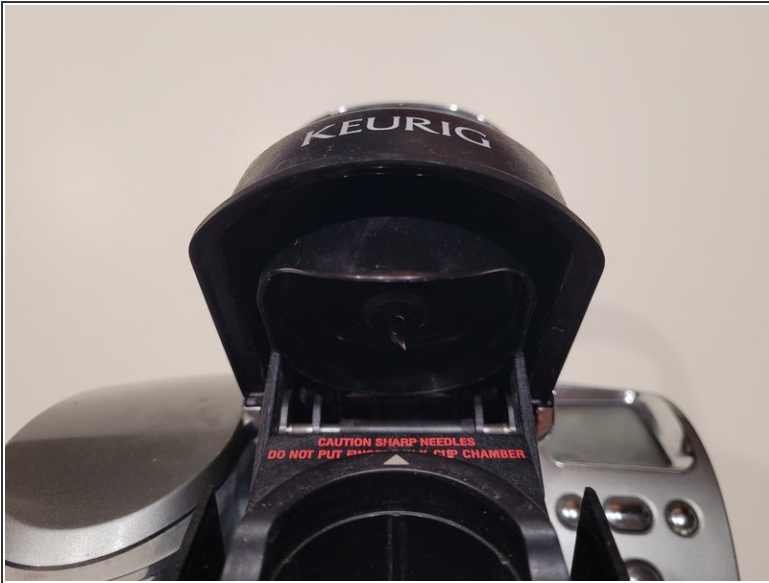
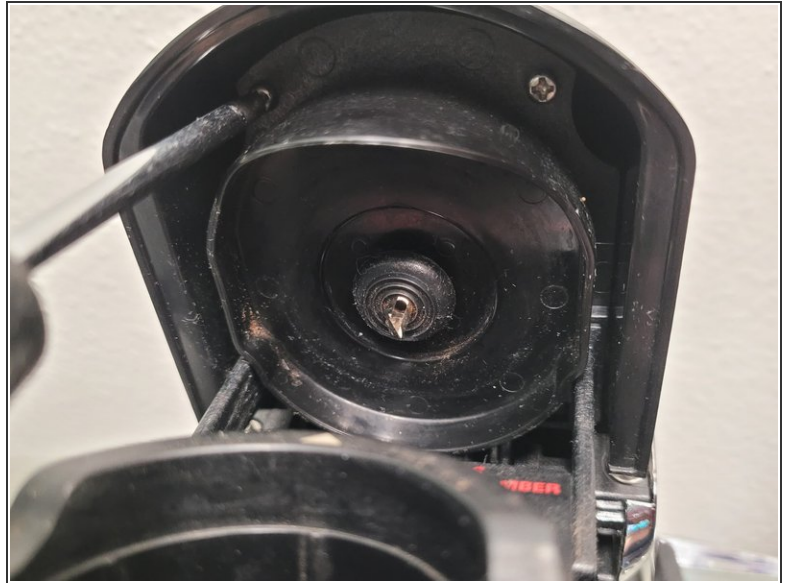
Step 1 — Check Valve

- Lift up the top lid.
- Remove the two screws with a Phillips #0 screwdriver.

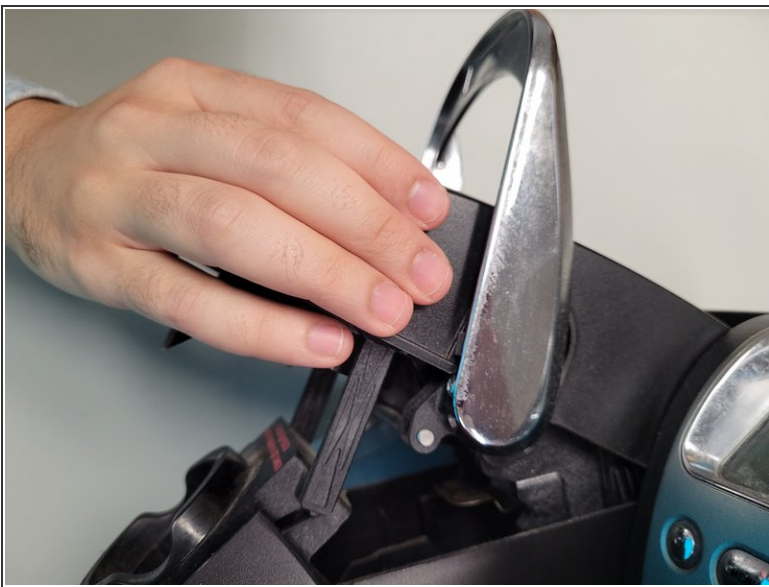
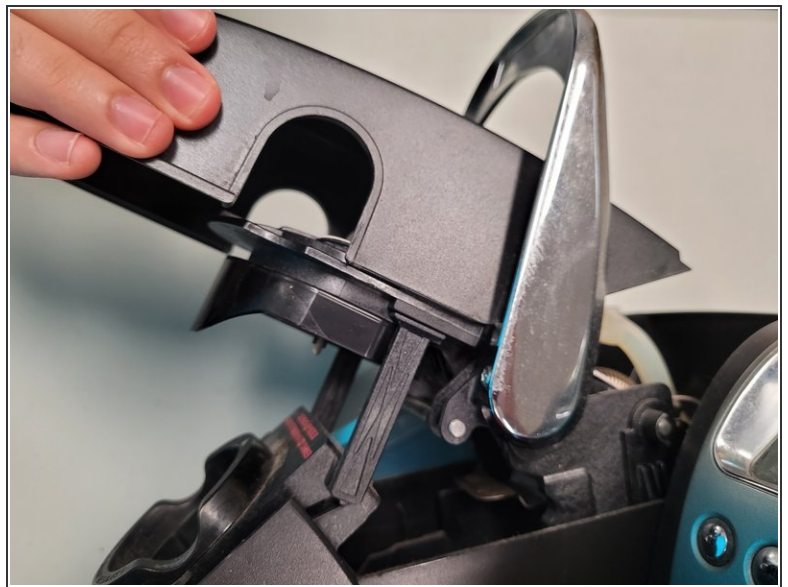
Step 2

- Push down on the lid.
- Lift up and remove the lid.

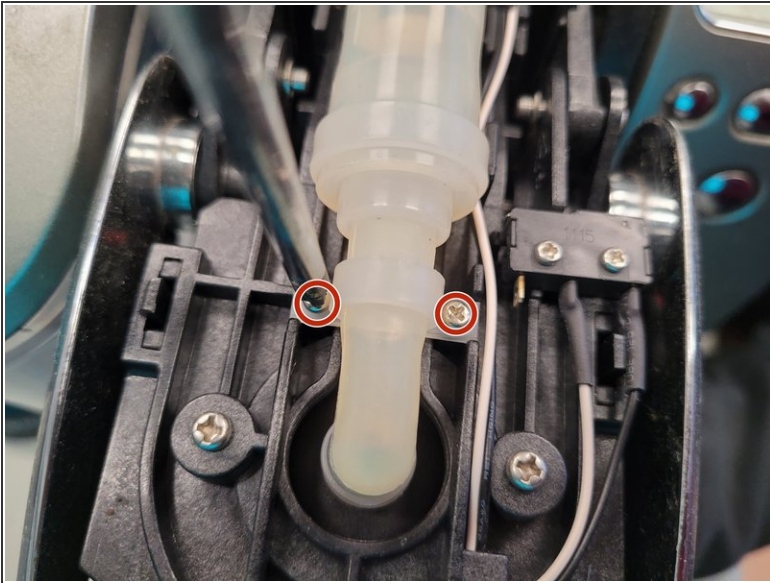
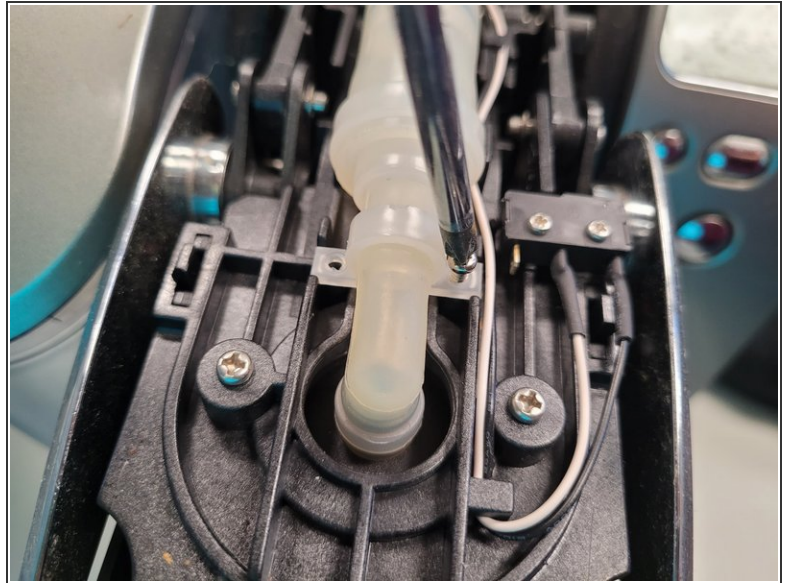
Step 3

- Using the Phillips #0 screwdriver, remove the two screws holding the tubing to the puncture needle.

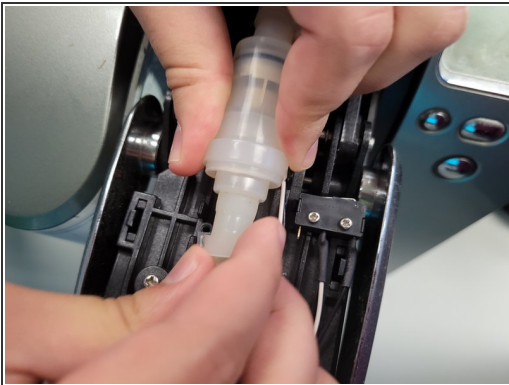
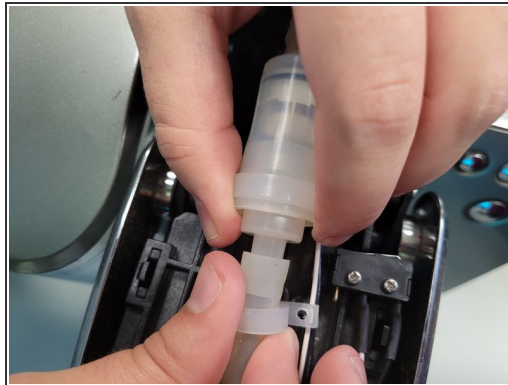
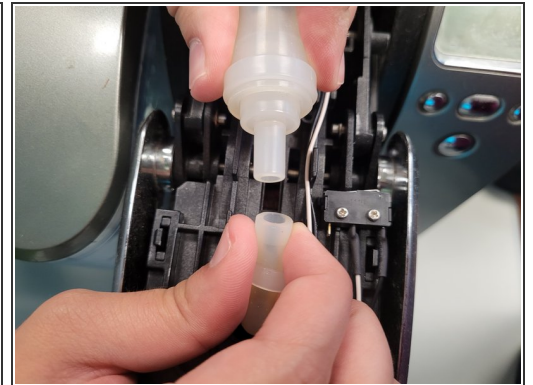
Step 4

- Twist and pull to disconnect the valve on that side.

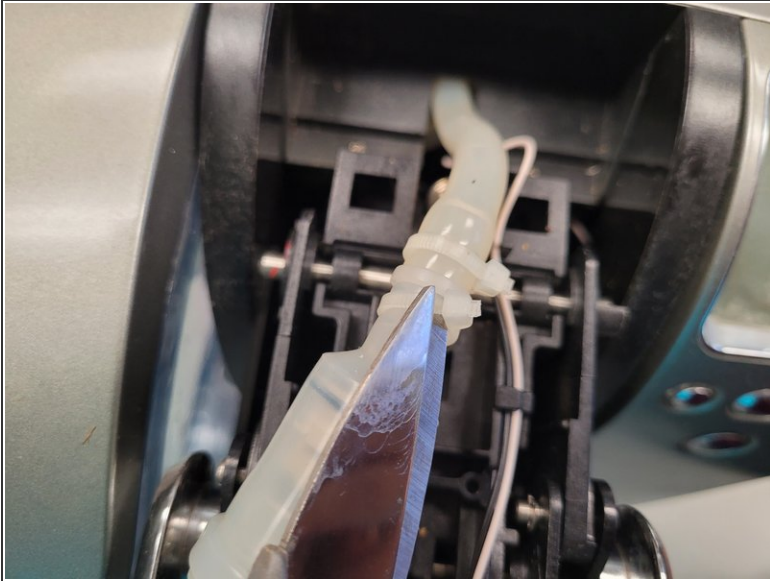
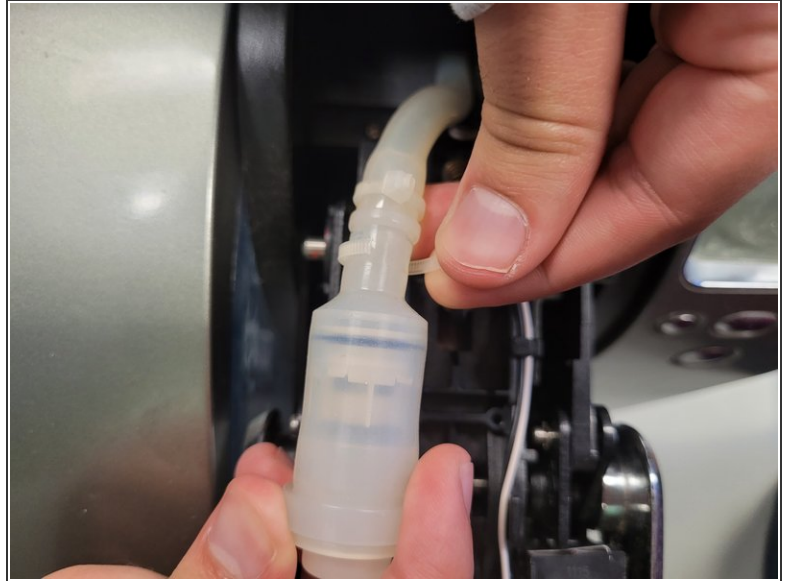
Step 5

- On the other side, cut the one zip tie closest to the valve.

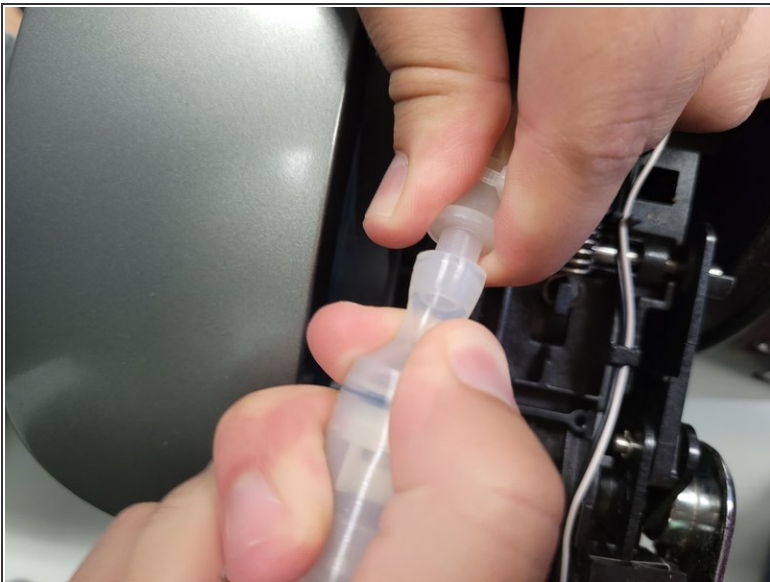
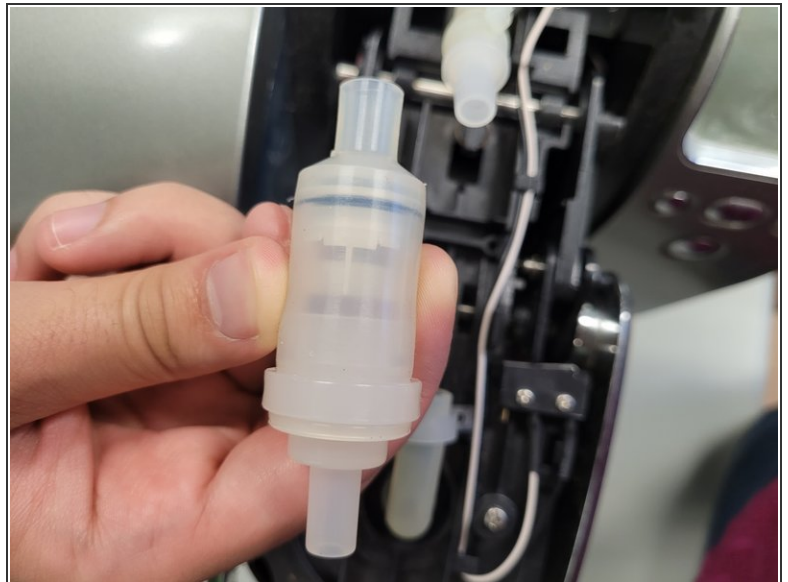
Step 6

- Twist and pull to disconnect valve on the other side.

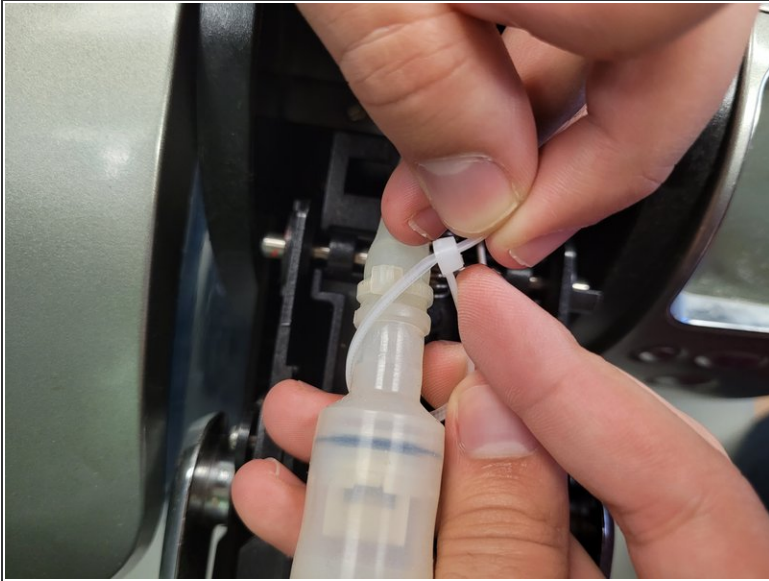
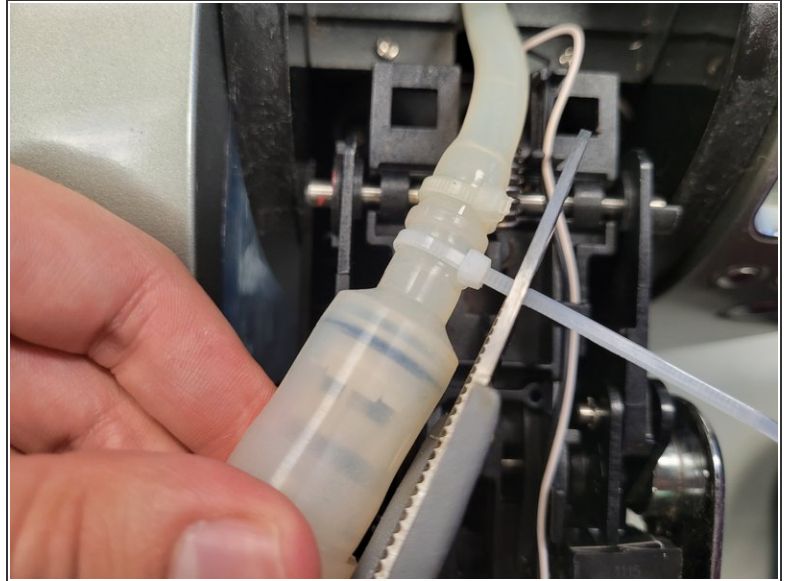
Step 7

- Reassemble the valve in place.
- Resecure it with a zip tie.
- Trim the excess plastic off of the zip tie.
