Nintendo Switch Right Joy-Con SL/SR Button Board Replacement

A bent SL/SR button board cable will cause the...

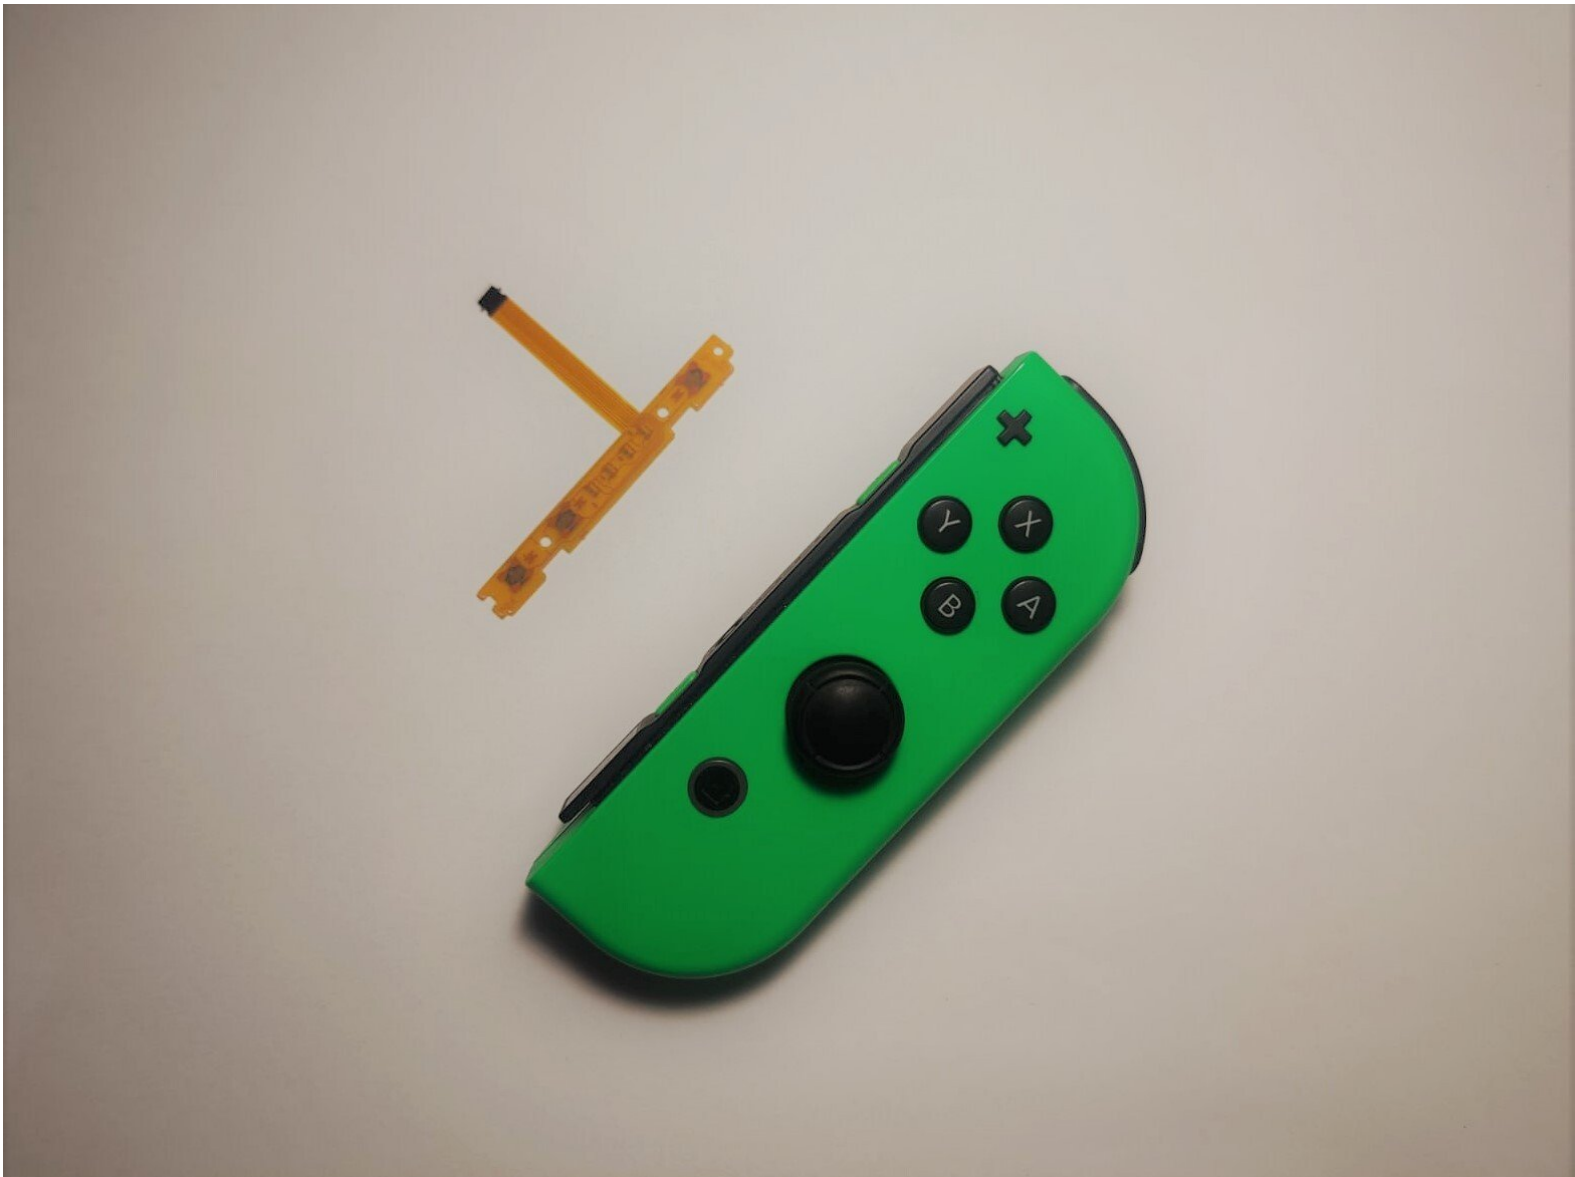
A bent SL/SR button board cable will cause the SYNC button, the LED lights and the SL/SR buttons to be unresponsive. This will make the Nintendo Switch Joy-Con unable to connect to a game console by itself without a second Joy-Con.

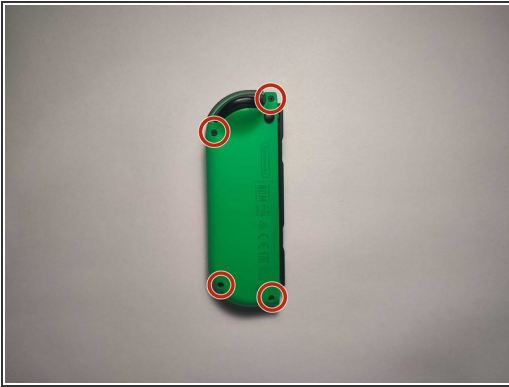
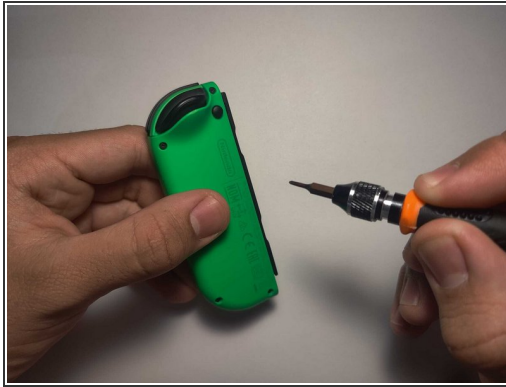
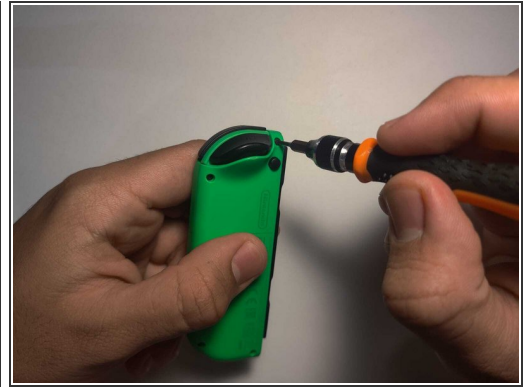
Step 1 — SL/SR Button Board

- Remove the four 6 mm screws visible on the back of the Joy-Con using the Tri-point Y00 screwdriver.
- ⓘ During the entire procedure, place the small screws somewhere you won't lose them and keep them organized.

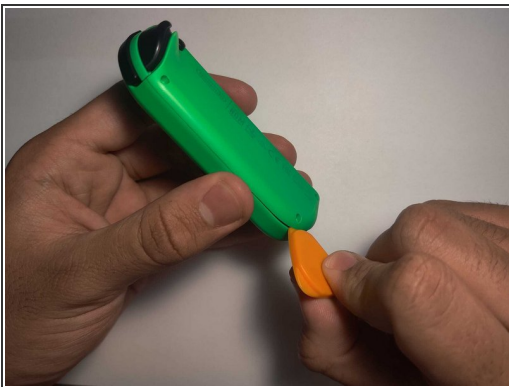
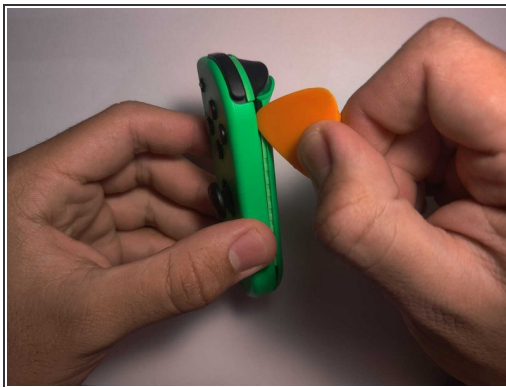
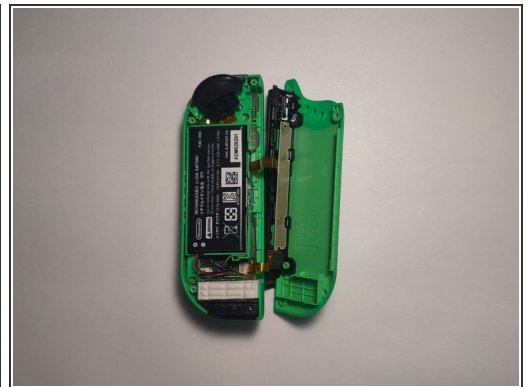
Step 2

- Open the Joy-Con by inserting the opening pick tool into the bottom corner and sliding it upwards.
- ⚠ When opening, be careful not to 'yank' the two halves of the Joy-Con far apart, as they are still attached by cables.
- ⚠ The ribbon cables are fragile. Forceful pulling may lead to device damage.

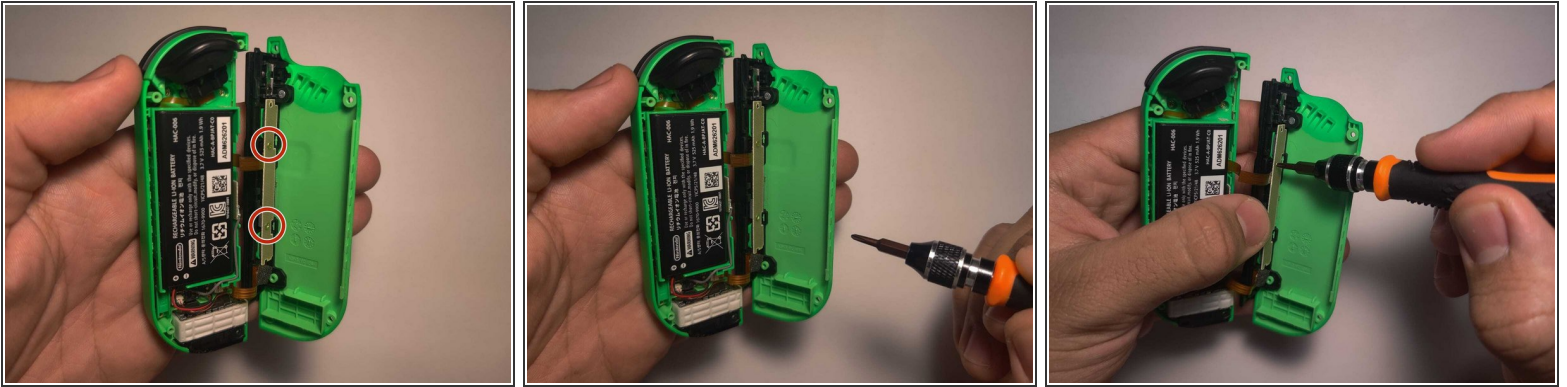
Step 3

- Remove the two 3 mm screws on the charging rail using the Phillips #00 screwdriver.
- ⓘ The part that needs to be replaced is the button board directly under these two screws.

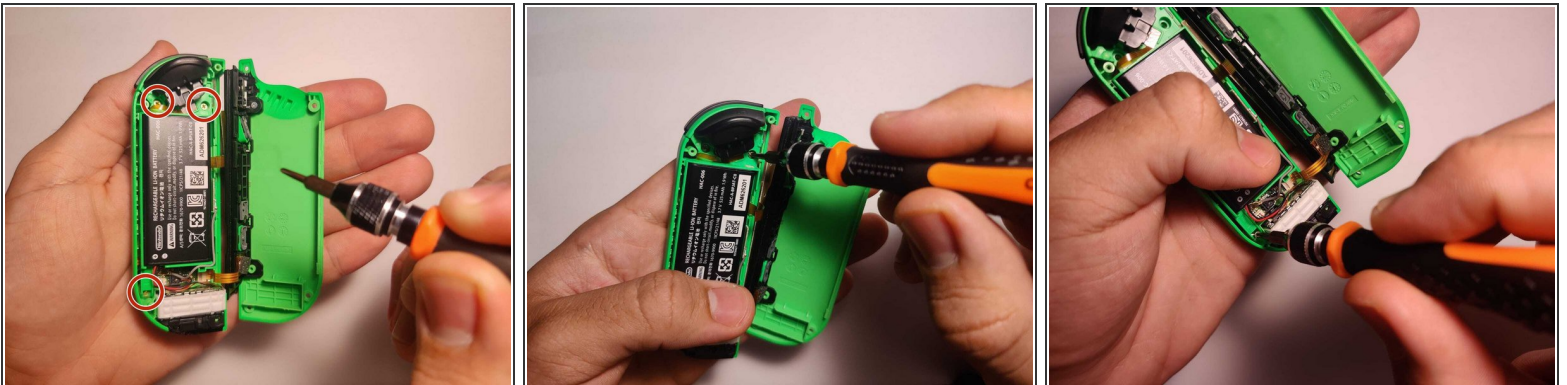
Step 4

- Remove the three 3 mm screw on the battery compartment using the Phillips #00 screwdriver.
- ⓘ With the battery compartment loosened, the locking tab holding the cable in place will be easy to access.

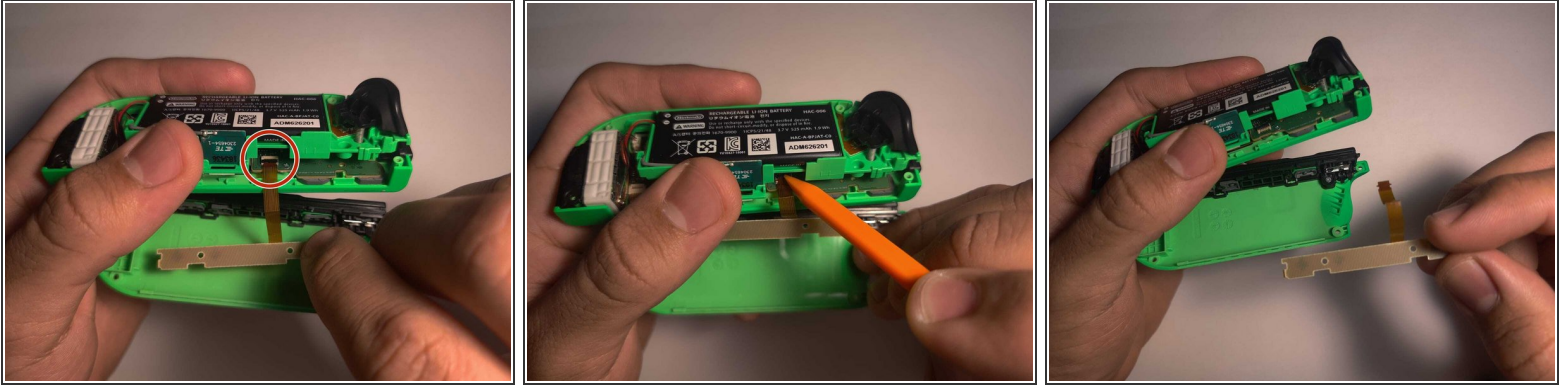
Step 5

- Use the plastic spudger tool to lift the tab lock holding the bent button board cable. Lightly lift the battery compartment to have more space while doing so.
- Once the tab is unlocked, remove the bent cable.

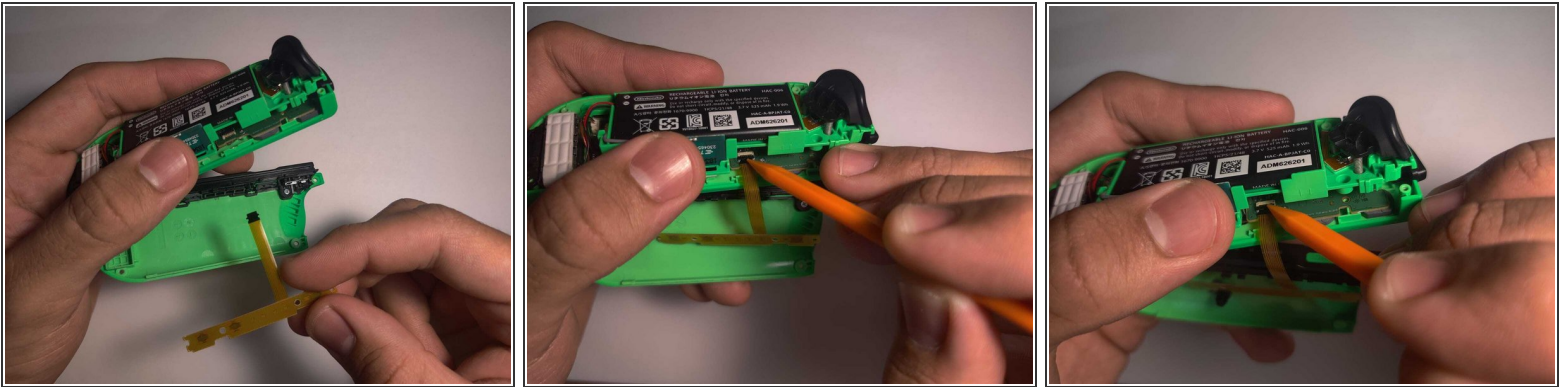
Step 6

- Insert the new replacement button board cable into the tab.
- Use the spudger to re-lock the tab to hold the new part in its place.

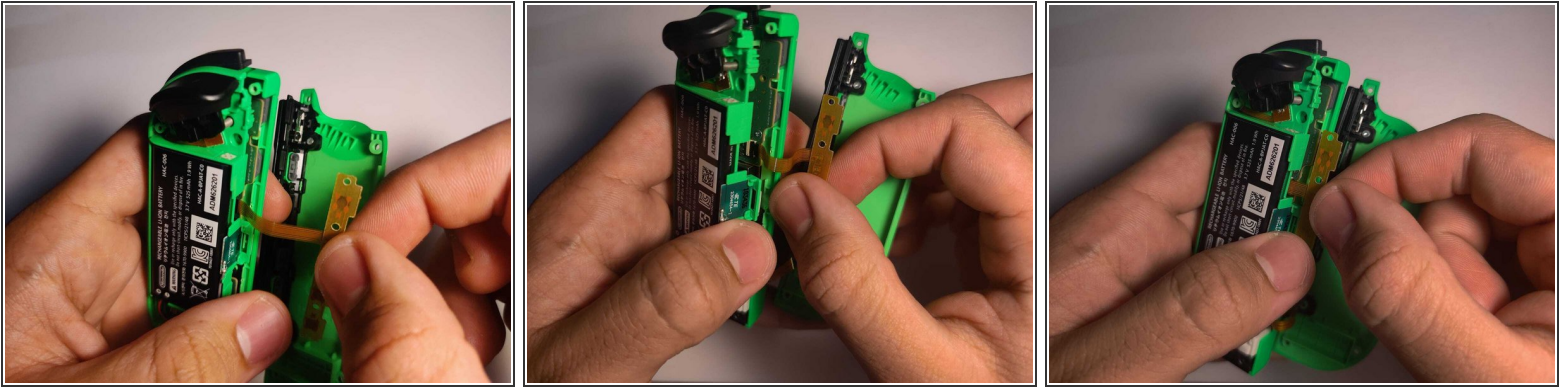
Step 7

- To avoid having the same problem in the future, make sure the new cable is bent ***under*** the battery compartment after reassembly.
- Lightly lift the battery compartment to make it easier to bend the new button board cable under it.
- ⓘ The space between the battery and the back shell of the Joy-Con is very tight, which caused the original cable to bend and malfunction. Inserting the new cable under the battery will give it more space.
