# Lenovo ThinkPad X1 Yoga (6th Gen) SSD Replacement

Written By: Taylor Morgan

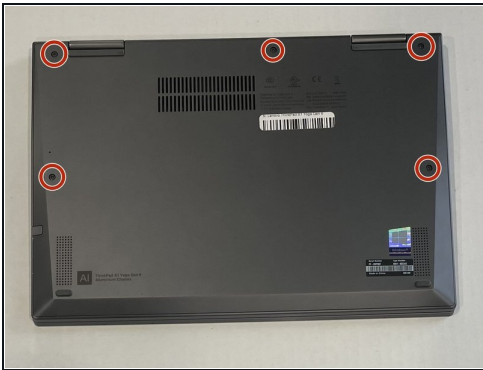
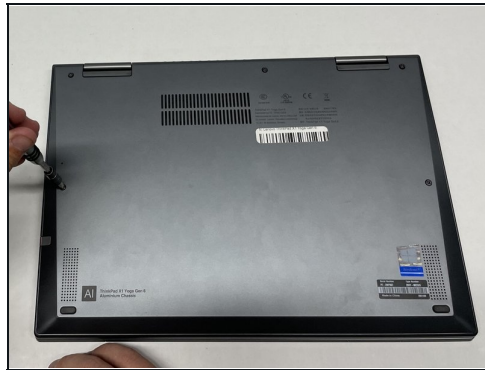
## Step 1 — Base Panel

- Use a Phillips #1 screwdriver to remove the five 5.0 mm screws from the base panel.
- Wedge a spudger between the base panel and chassis, and pry around the entire perimeter until you hear a pop and the base panel releases.
- Lift the base panel up and off of the chassis.
