De Dietrich Double Oven Control PCB Replacement

Repair an electric Double Oven. (UK and 240vac mains current) Repair a broken light and no lower oven working. No display or function buttons.

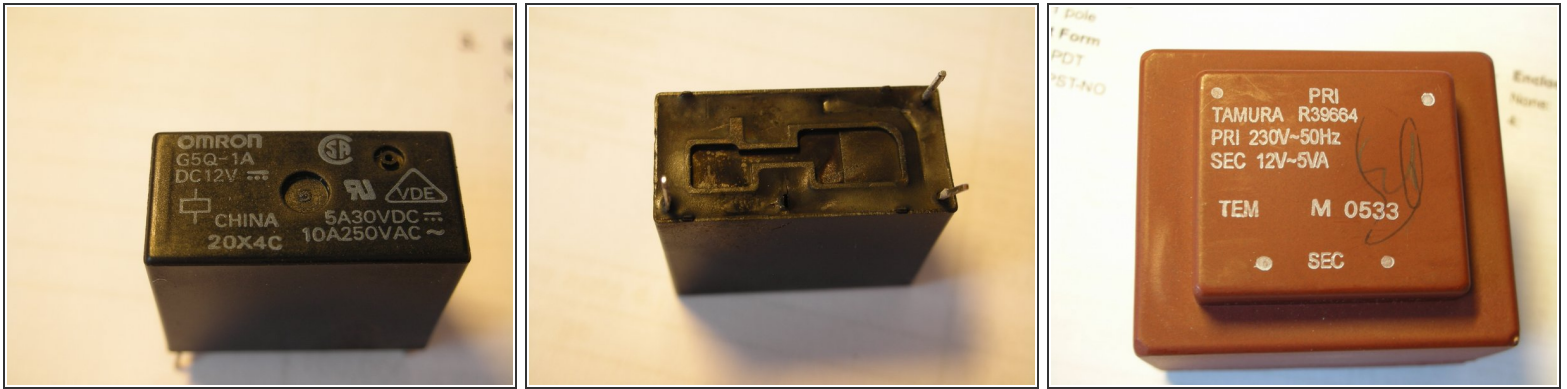
Step 1 — Control PCB

You will be working on live and exposed wiring components. Disconnect and switch off from wall outlet. No Internal light working and lower oven function or display. Note that this oven has two similar control pcb's. You can compare one board to the other.

- The lamp has been replaced but still not working. The next thing to do is check out the lamp wire end connections, the terminals went high resistance on my unit, replacing the push on connectors was easy. The connectors are the type used on cars and I had some handy. Re-testing still no light.

- Tracing the lead wires back to the control pcb I noticed the small relay looked bad and this only applied a neutral return.
 - Pulling the relay showed more blackened marks. So the relay was replaced. Success now the light was on again.

- Moving on to the lower oven with no display or function buttons working. Checking the output from the small 12v 5VA transformer was zero. 240V AC input was there. A slight bulge on the top of the transformer confirmed a problem, it was also coming out. Resistance on the primary showed o/c windings.

- A new replacement from Farnnell was fitted. Part number 1689081, (Manufacturer part number 44231)
 - Testing and the controls were restored to normal.

The new transformer was made by Myrra (not Tamura as in the photo) and that a Myrra unit was working on the other controller pcb. Guess the factory used both.
