iRobot Roomba 650 Side Brush Motor Replacement

If the motor for your Roomba's side brush needs replacing, give this guide a look.

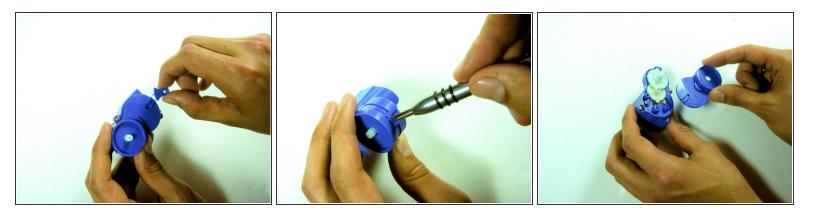
Step 4 — Gear Box Cover

- Remove the screw on top of the housing. The small plastic piece should come right off.
- Carefully pry open the gear box by inserting a flat head screwdriver in the slot on the end of the box. *This might be difficult and require some wiggling of the screwdriver.*
- The cover should come right off.
