LG Optimus Exceed 2 Volume Button Replacement

Written By: Carl Dorvilus

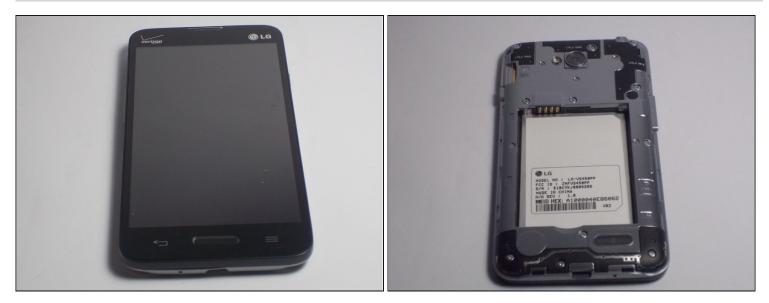
Step 1 — Battery

• Flip the device over and remove the back covering.

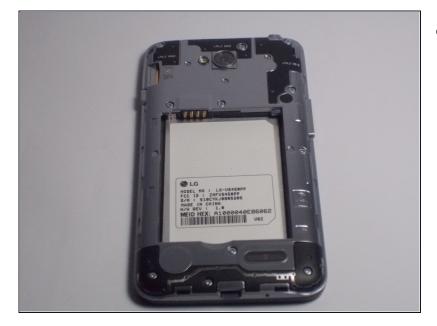
• Push on the top of the battery downward and pull the battery off of the device.

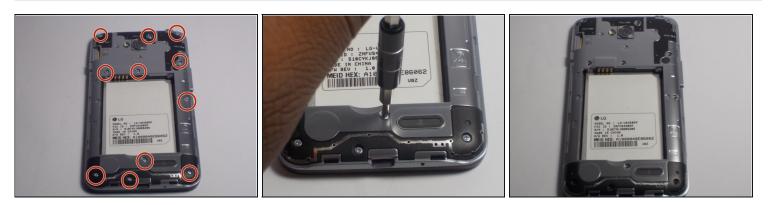
Step 3 — Rear Camera

• Remove the eleven 4mm screws using a Philips head screw driver.

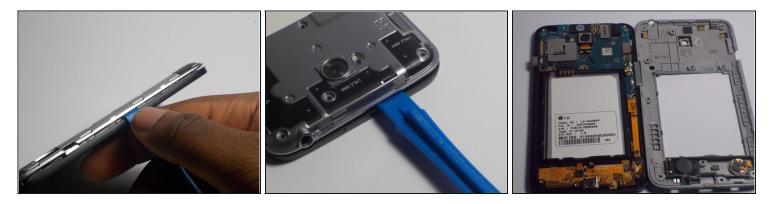
• Insert the plastic opening tool into the side of the device and pry off silver covering. Push up against the back covering when the tool is inserted to detach from the phone.

(*i*) Make sure to detach all sides of silver covering before lifting it off the phone.

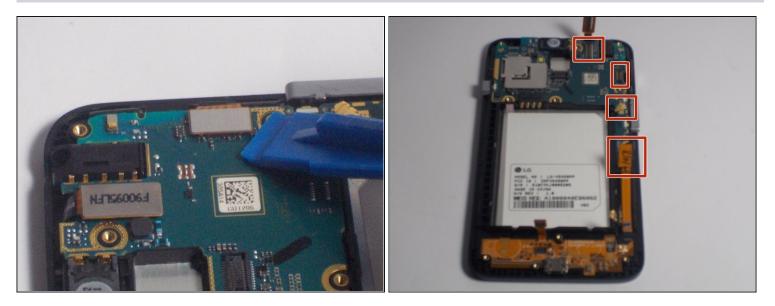
Step 7 — Motherboard

• Disconnect the remaining ribbon plugs and connectors. (Only remove the highlighted cables for the removal of the logic board.)

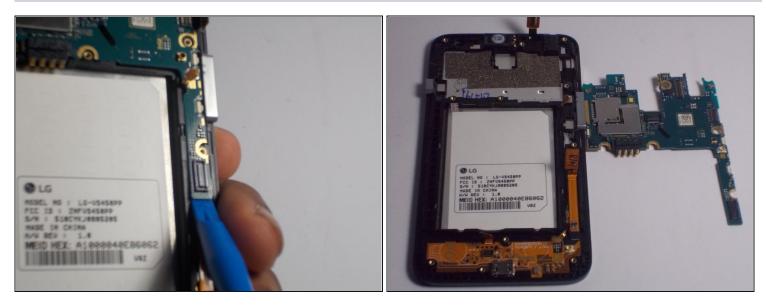
• Push the blue lifting tool up underneath the logic board and pull it upwards removing it from the device.

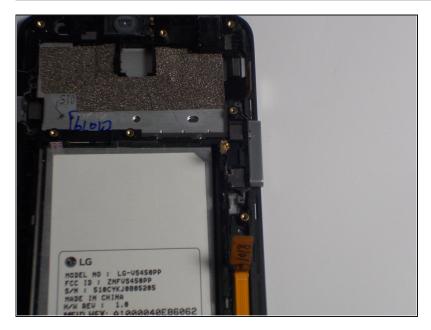
Step 9 — Volume Button

• Begin this guide by completing the LG Optimus Exceed 2 Screen Replacement to step 2.

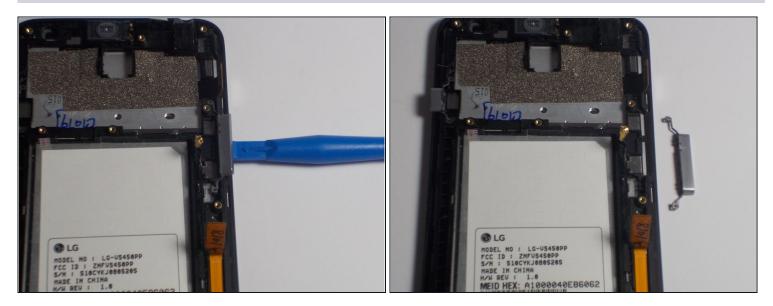
• With the device facing up lift with your fingers or the blue lifting tool to remove the volume buttons from the device.
