# Garmin Nuvi 2589LMT Microphone Replacement

A simple guide to replace your Garmin Nuvi 2589LMT Microphone.

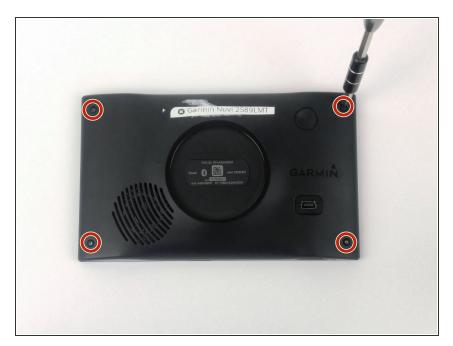
# **Step 1** — Back Panel Assembly

Using the T5 Torx Screwdriver, remove all 4 of the 5.7mm screws from the back of the device.

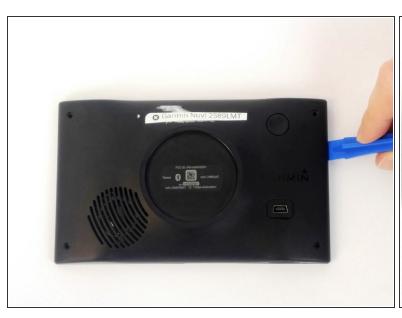
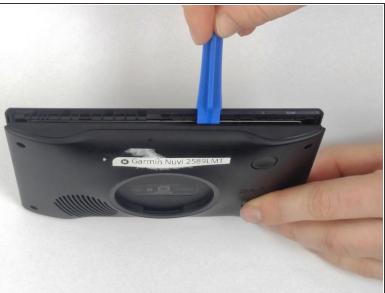
# Step 2

- Using the plastic opening tools, pry the shorter sides of the device apart.
- Once a gap has formed at the top of the device, insert the opening tool into the gap and slide it along the top of the device. Repeat for the bottom edge of the device to separate the LCD screen from the back.
- ⚠ Do not disconnect or tear the ribbon wiring, located at the bottom of the motherboard, when removing the back of the device.

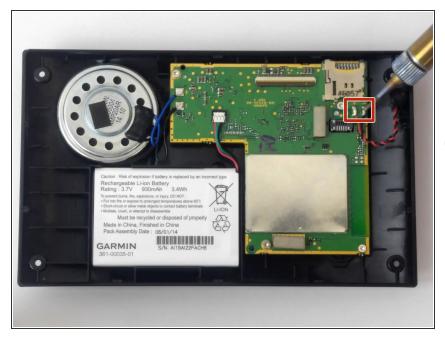
## Step 3 — Microphone

- Using a soldering iron, desolder the wire connection at the two soldering points between the microphone and the motherboard to remove.
- (i) Learn more about soldering and desoldering connections <u>here</u>.

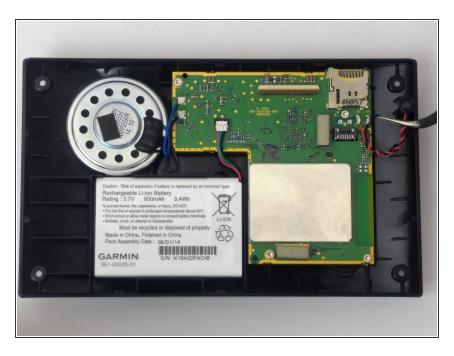
## Step 4

Using the angled tweezers, grab the microphone wires and gently pull to remove the microphone from the device.
