Beats Solo 2 Wire Replacement

We are replacing the internal core wire to fix the right speaker not working.

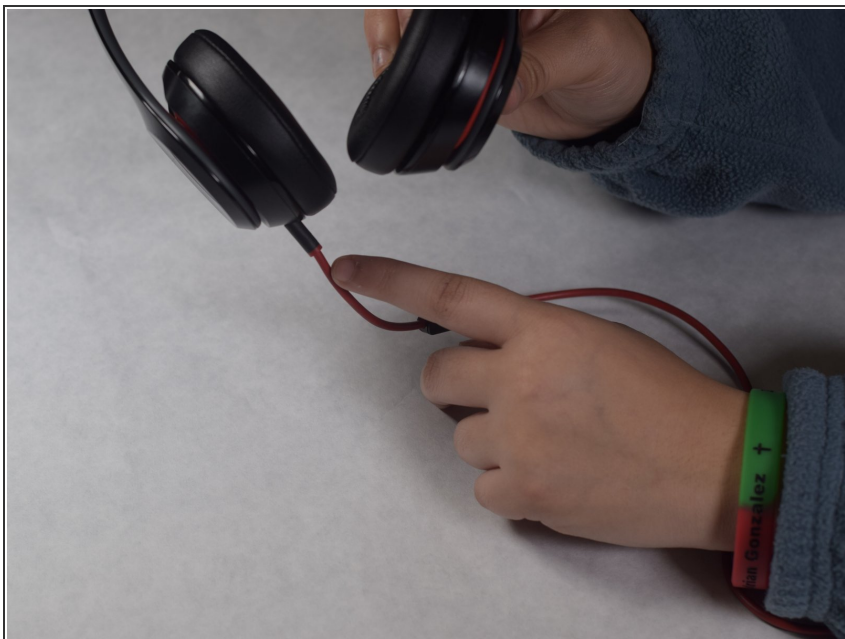
Step 1 — Core Wire

- Pull out the wire from the beats. The wire is a jack wire and requires nothing special to remove.

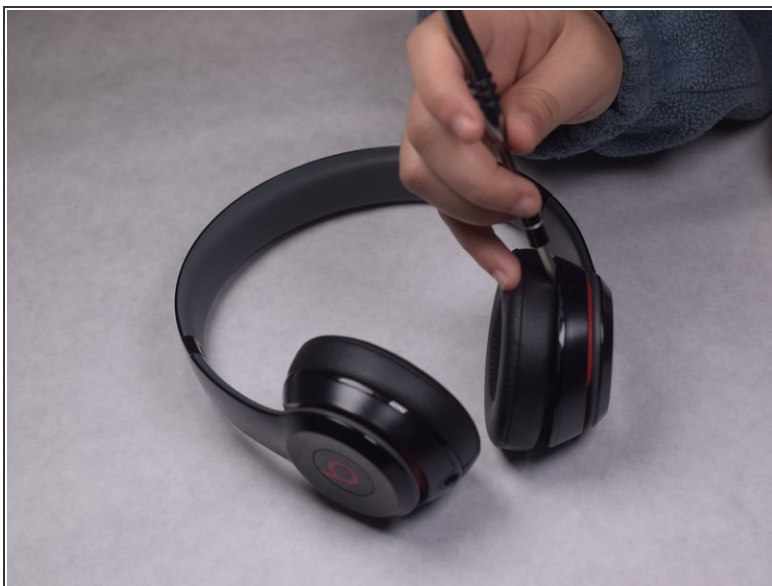
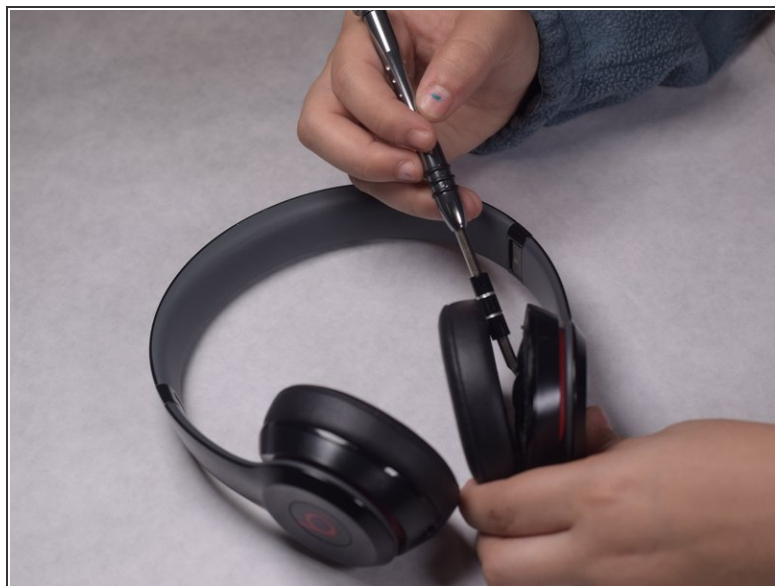
Step 2

- Remove the ear cushions from the headset. The preferred method to do this is to use a screwdriver and pry the cushions off.

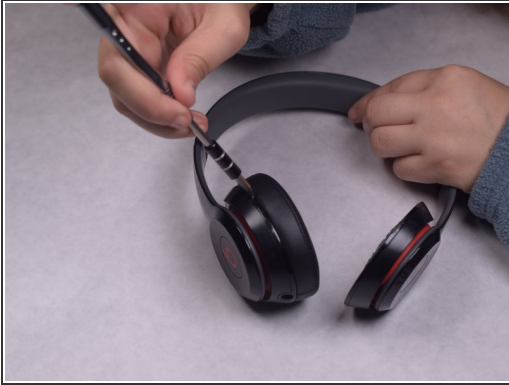
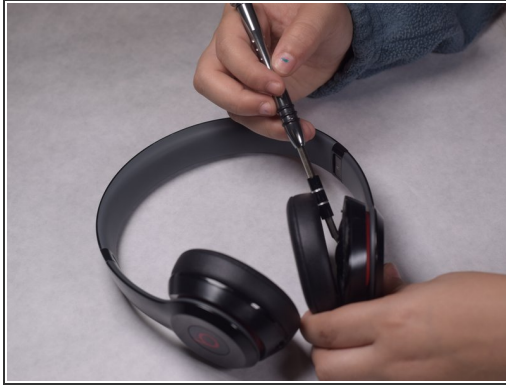
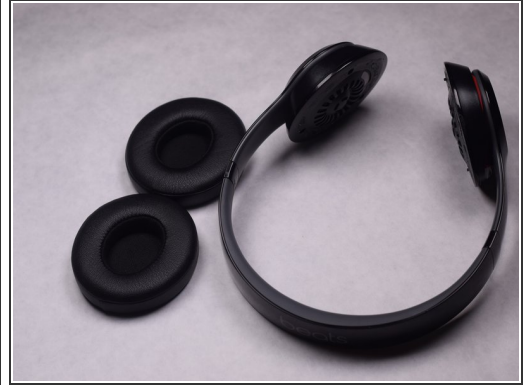
Step 3

- Remove the second cushion until both cushions are removed.

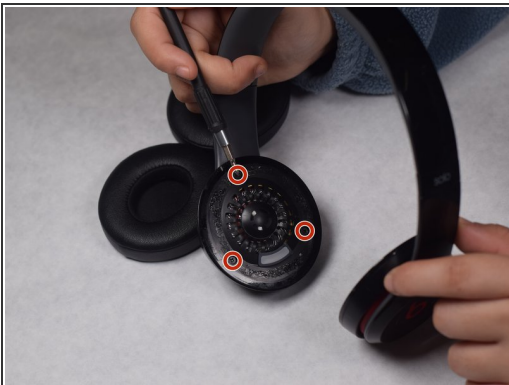
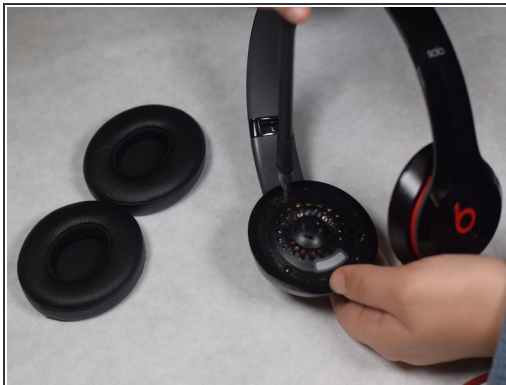
Step 4

- Remove the screws from both ear bases.

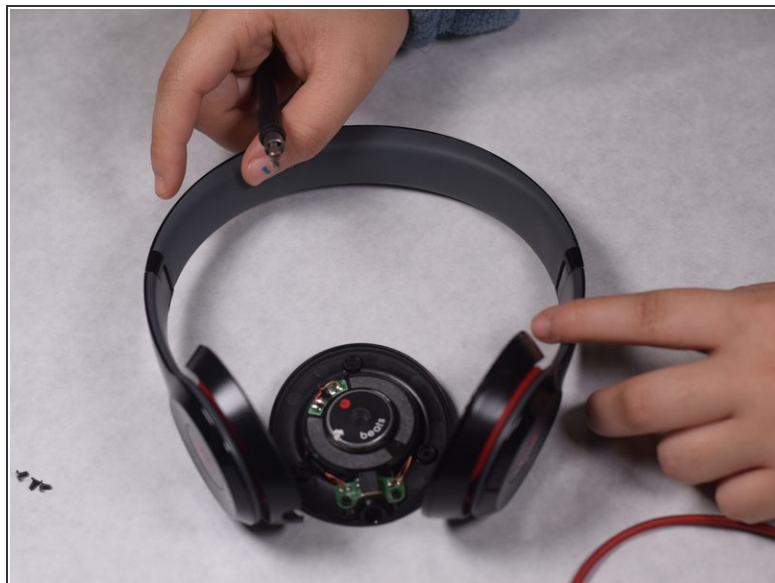
Step 5

- Once the screws are removed, pop off the inner speakers. Do this for both sides

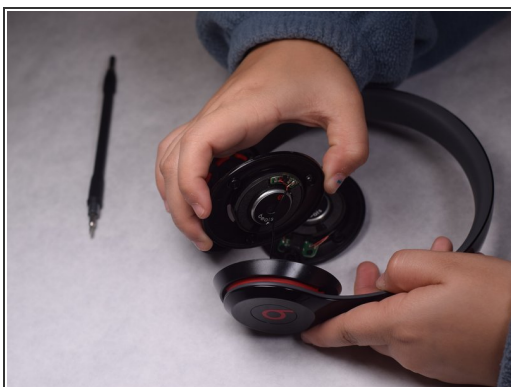
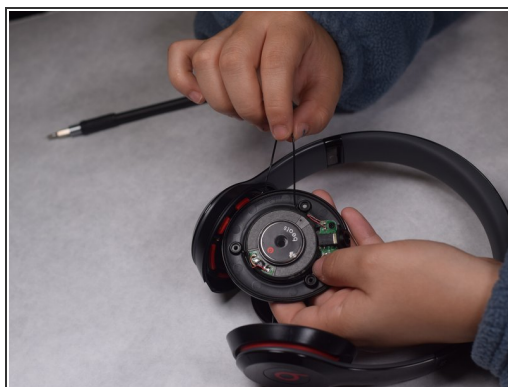
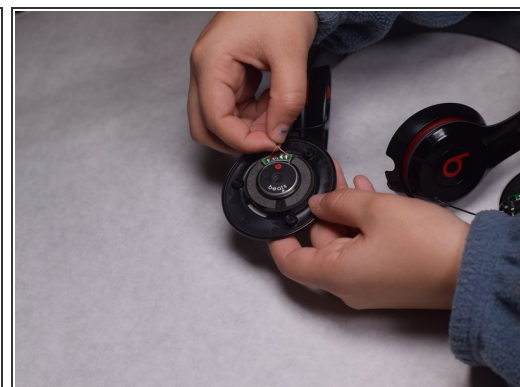
Step 6

- After you have removed the second internal speaker, you can begin the process of removing the wire. BE CAREFUL with this step, make sure you don't pull off the circuit board.

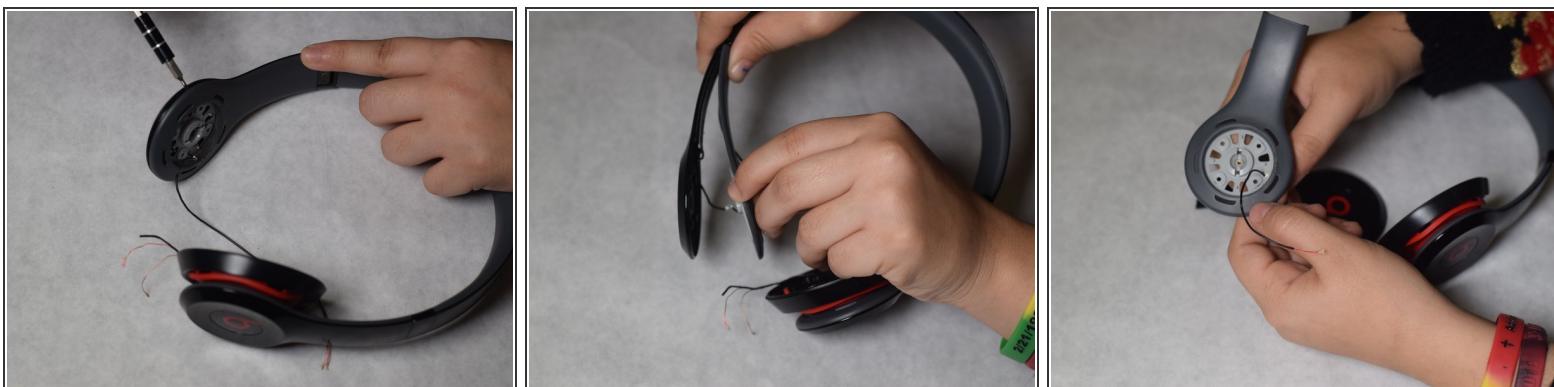
Step 8

- slowly pry away cover
