1999 GMC Sierra Radio Replacement Radio Replacement

Replacing a radio in a 1999 GMC Sierra SLE. Based off replacing a stock radio with a XO Vision XD107BT radio.

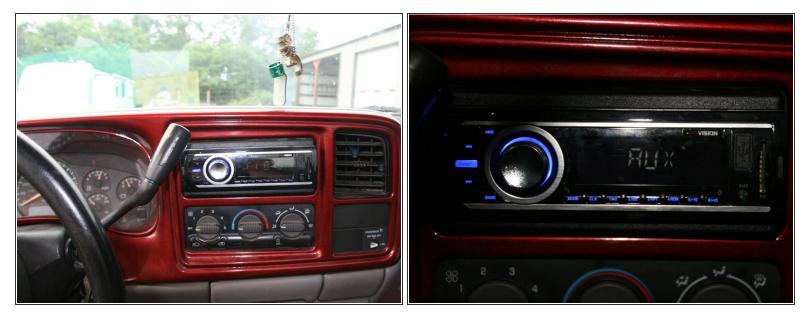
Step 5

Replace dash face! Then you are finished!
