# Lenovo ThinkCentre A70z Backlight Cable Replacement

The ThinkCentre A70z Monitor lamp turns off so can't see display without a light to verify LCD screen is working.

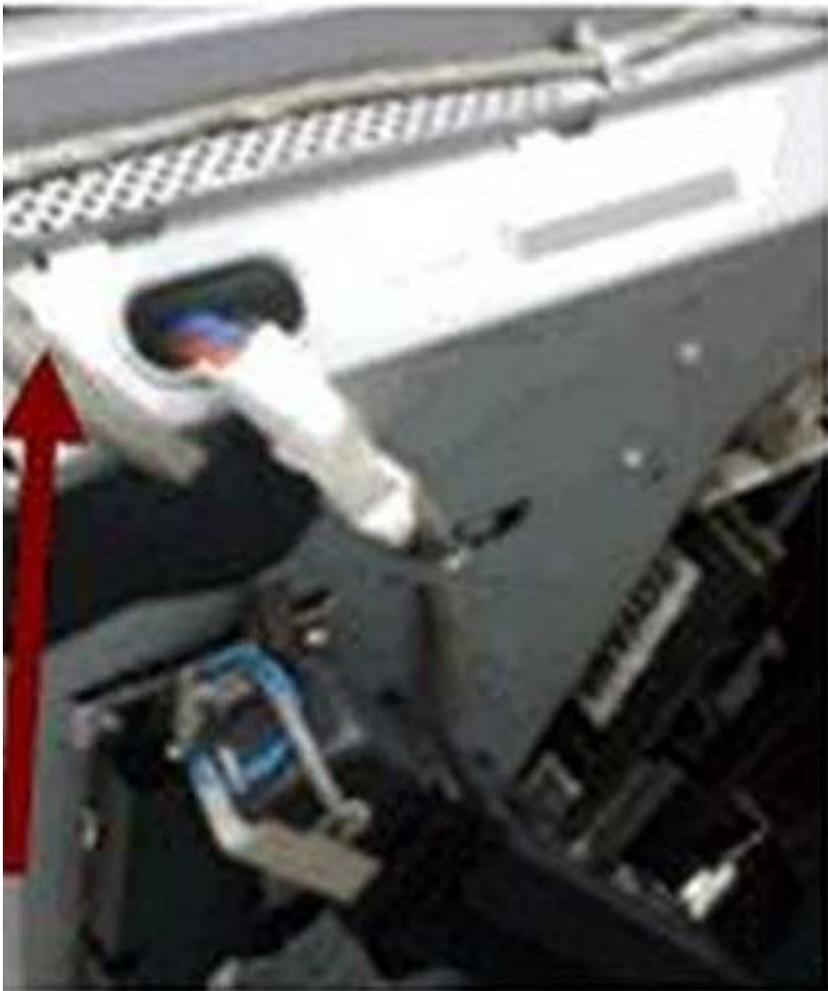
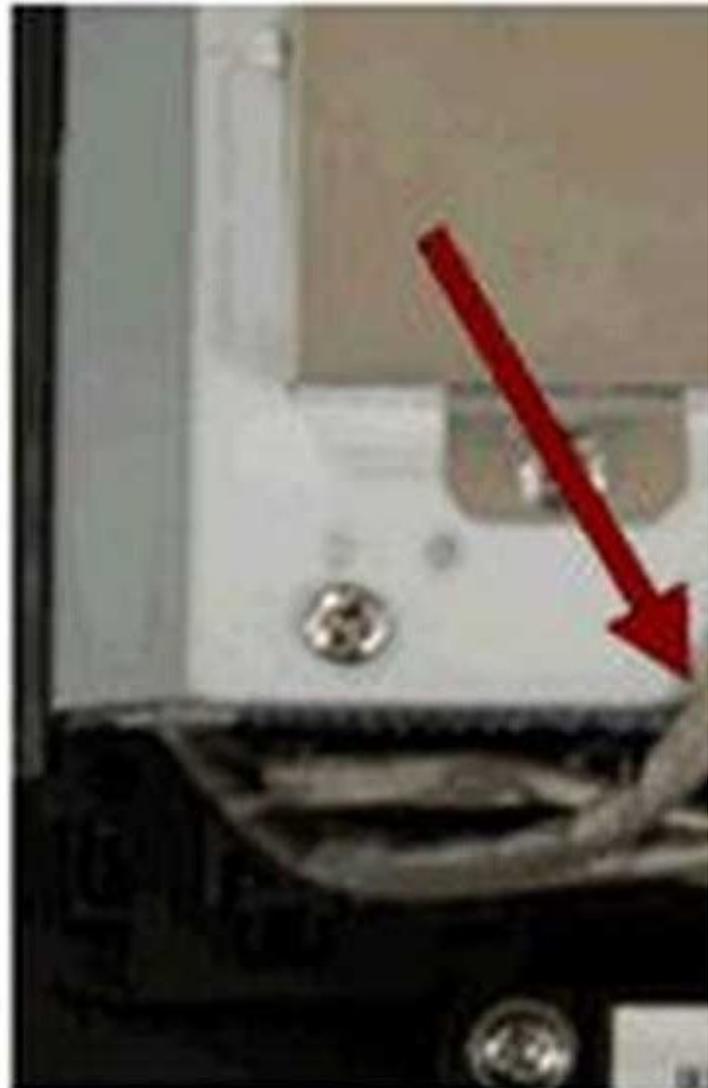
The issue is caused by the conductive tape wrapped around the backlight cable as seen below.

The issue has a low failure rate with the woven type of conductive tape. However, has a high failure rate with an aluminum foil type of conductive tape.

LG panel mentioned, "do not attach a conducting tape to lamp connecting wire directly. If the lamp connecting wire attach to a conducting tape. LCD module will have a risk for low luminance.

I removed the conductive tape wrapped around the backlight as noted and now the computer is working great again other than a login issue that will be corrected with a Windows 10 reset or I'm thinking a fresh install of a Linux OS for a multiboot system.

- Remove conductive tape wrapped around the backlight cable as below seen below.
- The issue has a low failure rate with the woven type of conductive tape. However, has a high failure rate with an aluminum foil type of conductive tape.

- Order special tape that has sponge as noted: 03T9708 34.3BE7.001  
FRU\_EMI\_GASKET\_MB\_SHEILDING\_TOYAMA
- Replace previous conductive tape with new tape 03T9708 after Removing original tapes.
