Philips Wake-Up HF3520 Power supply repair

The IC (chip) inside the lamp seems to die...

Written By: Thomas Widmaier

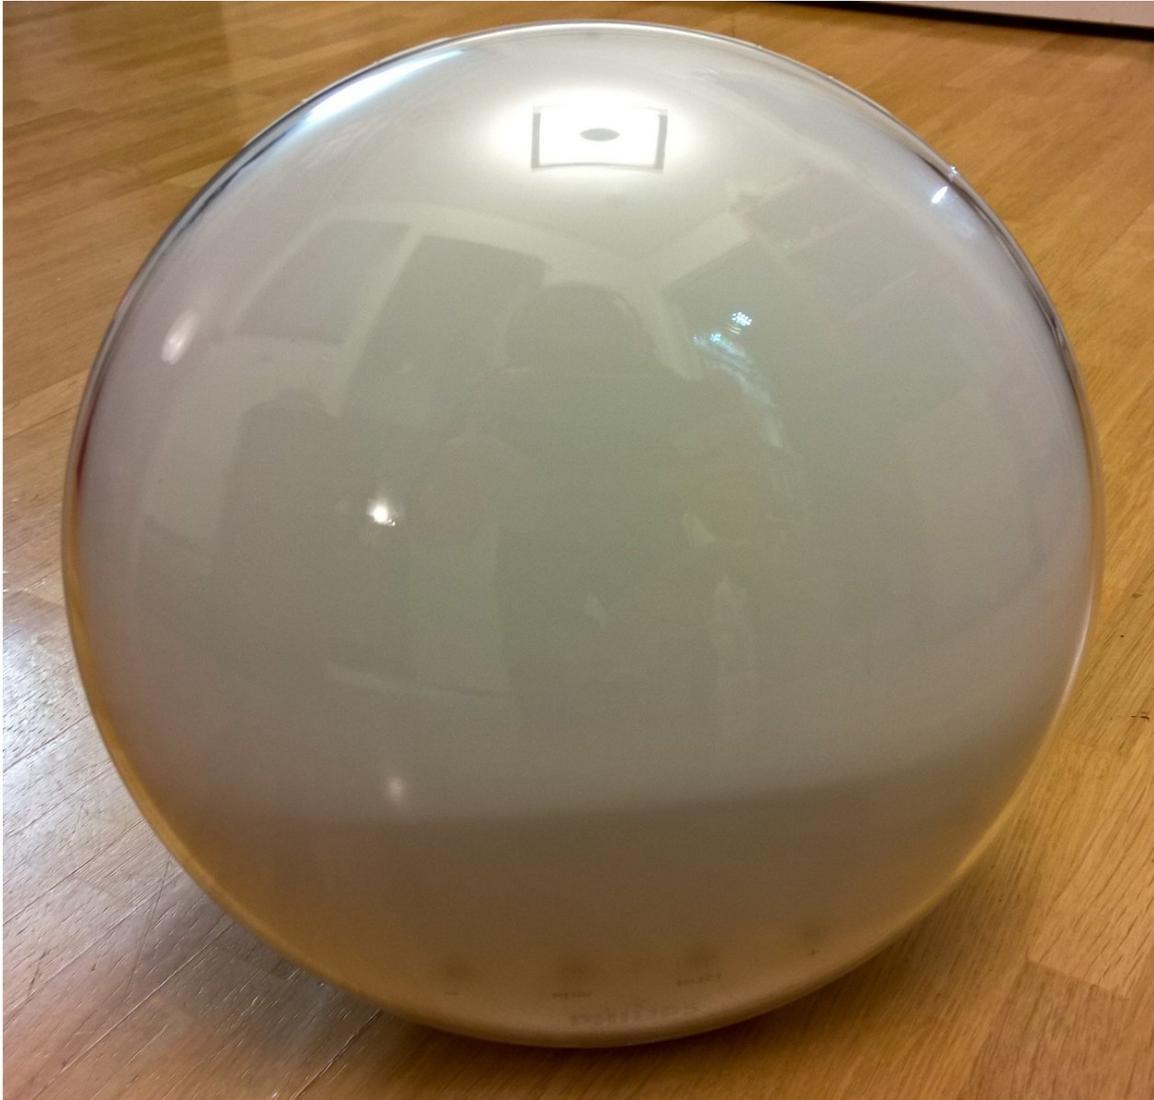
The IC (chip) inside the lamp seems to die slowly resulting in flickering/flashing lamp operation when using the radio. Also, the buttons may become unresponsive.

The problem occurs specifically when the device is cold and/or humid. Heating up the IC makes it work again.
