Farberware FSTO100 Heating Mechanism Replacement

Written By: Tony Wang

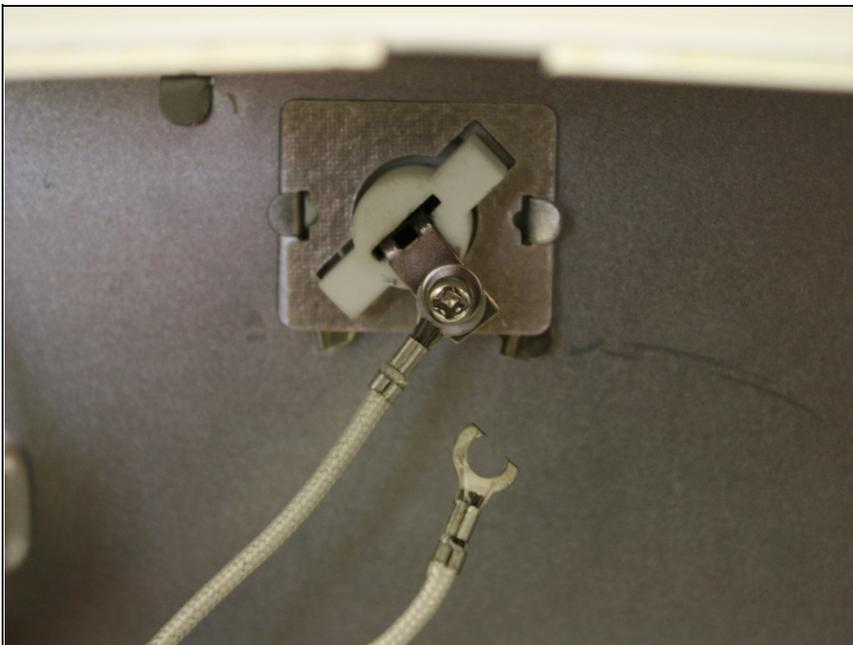
Step 1 — Heating Mechanism

- remove the screw at its original attachment point.
- Check if the lead wire is broken

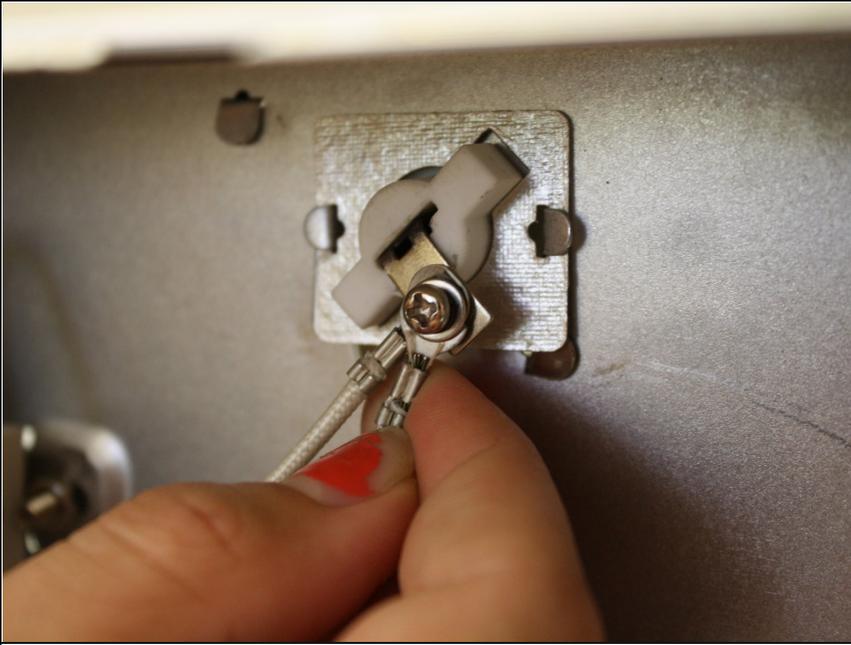
Step 2

- Make sure that the lead is attached and in contact.

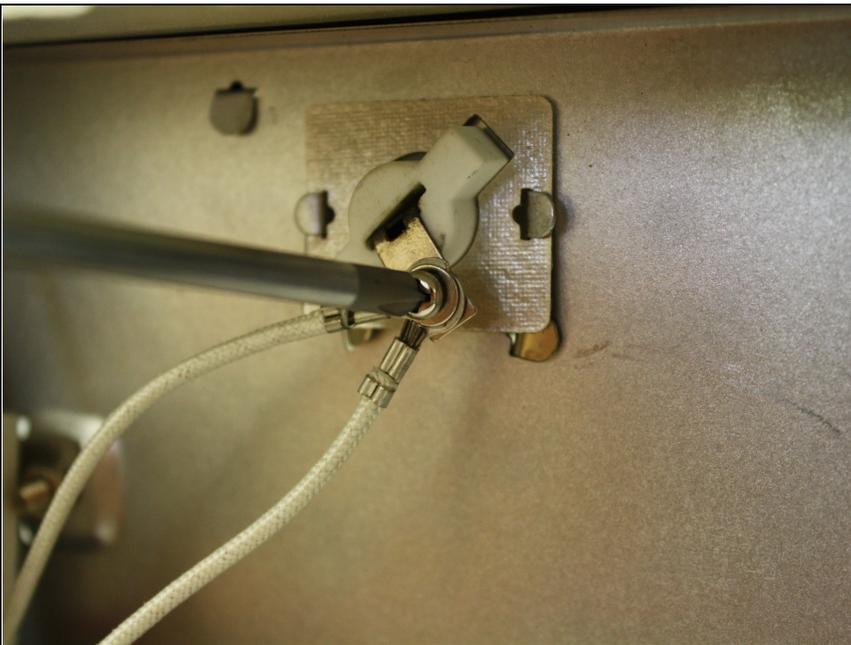
Step 3

- Retighten screw to secure lead.
