Nokia Lumia 925 Motherboard Replacement

Written By: Joseph McCoy

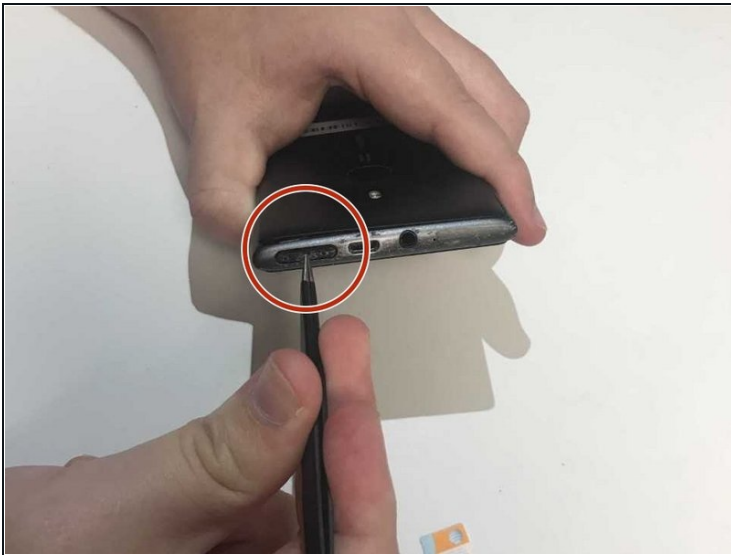
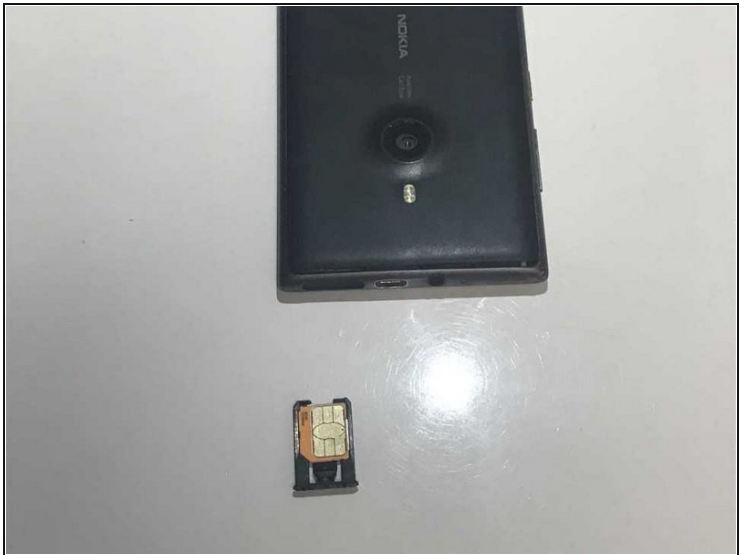
Step 1 — Motherboard

- Remove the sim card holder by inserting [tweezers](#) into the hole. Push down and the holder will spring back up.
 - Pull out the holder until it is completely separate.
- ① Something like a paperclip will work if there are no tweezers available.

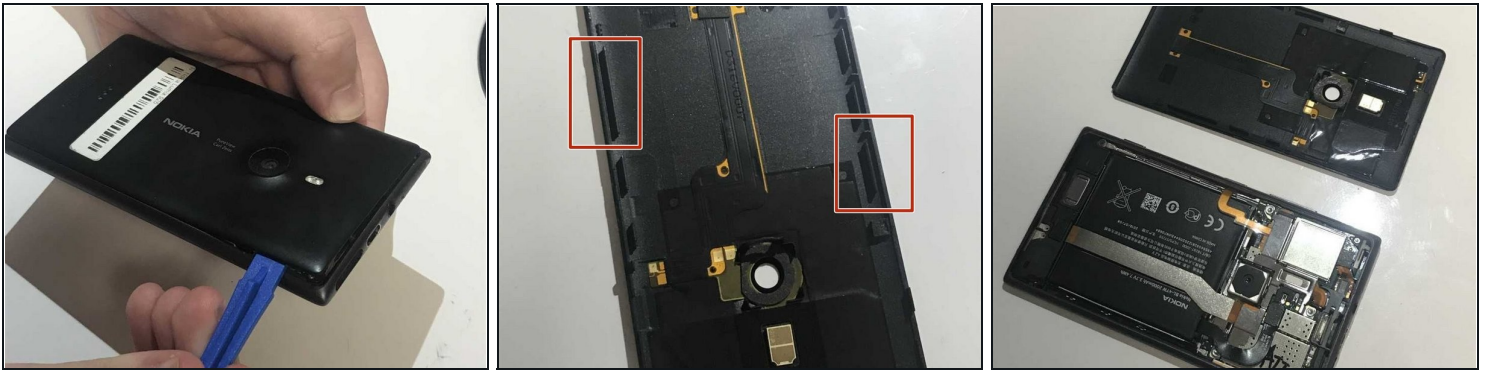
Step 2

- Slide a plastic opening tool under the back cover.
- Slide the tool around the outsides of the cover to fully dislodge the pins holding the cover to the phone.

⚠ Some pins are facing the opposite way from the others.

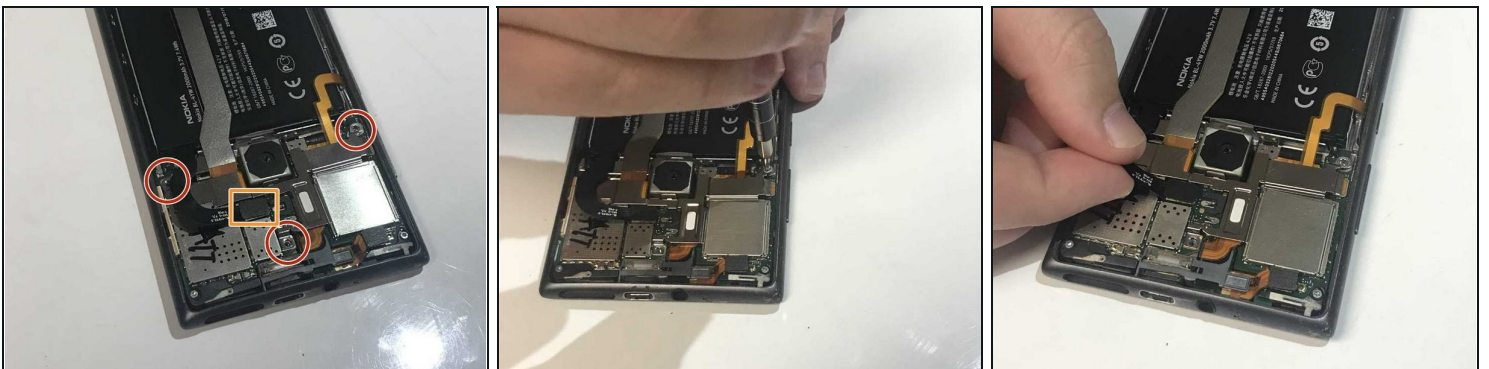
Step 3

- Remove the 3 screws using the T7 Torx screwdriver.
- Unclip the black tab connector.

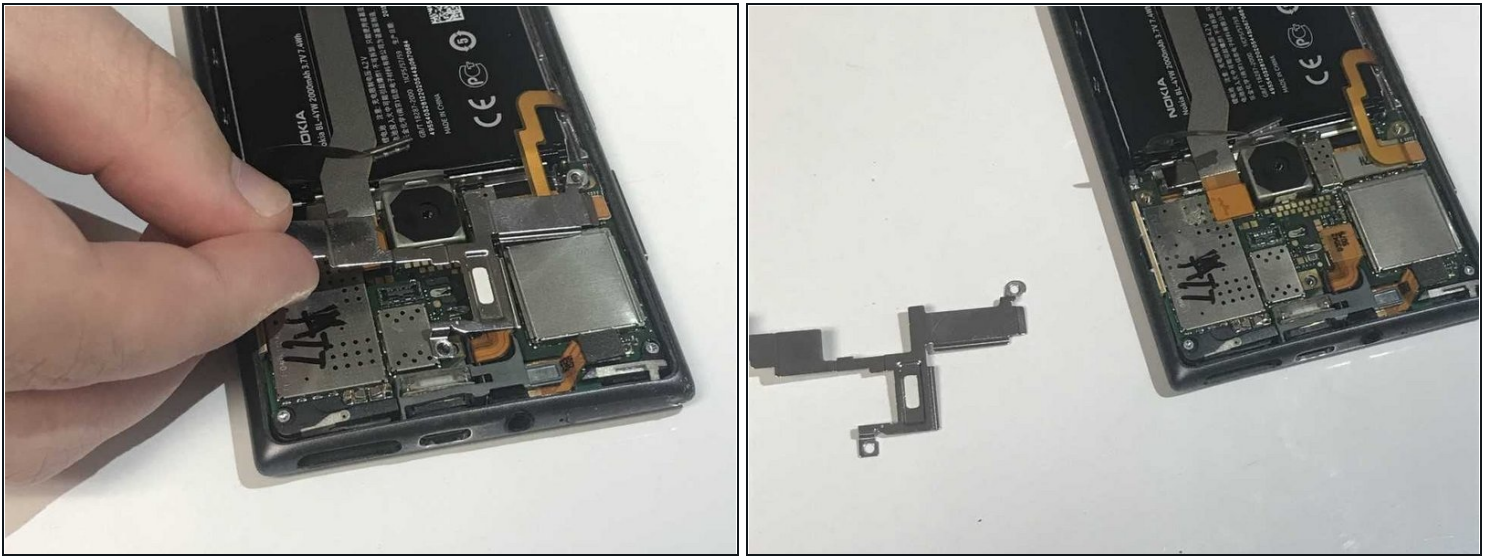
Step 4

- Remove the silver metal cover.

⚠ Be careful of the tape under the right square side of the panel. Using a spudger helps.

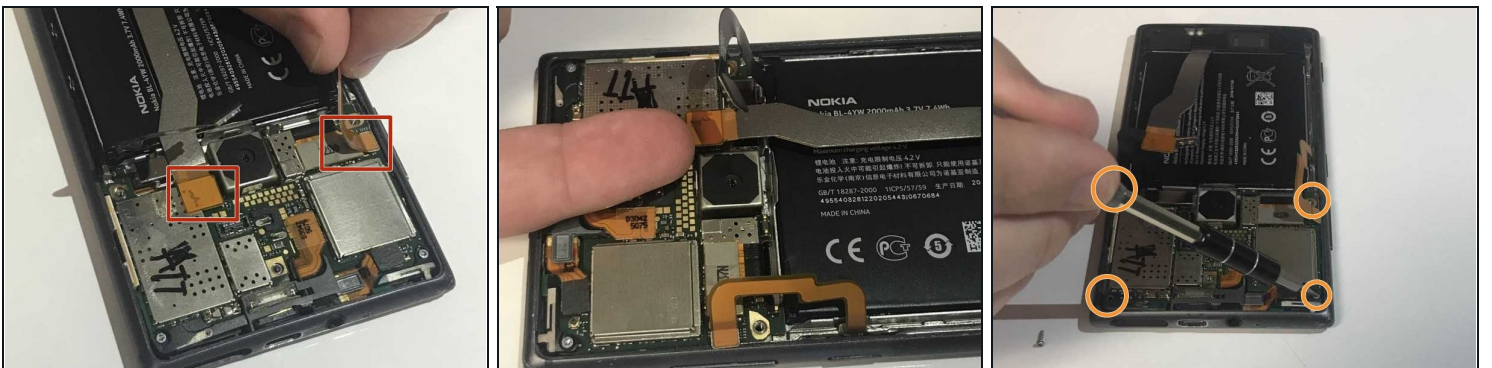
Step 5

- Unclip the two orange tabs.
- Remove the four silver screws using the T5 Torx screwdriver.

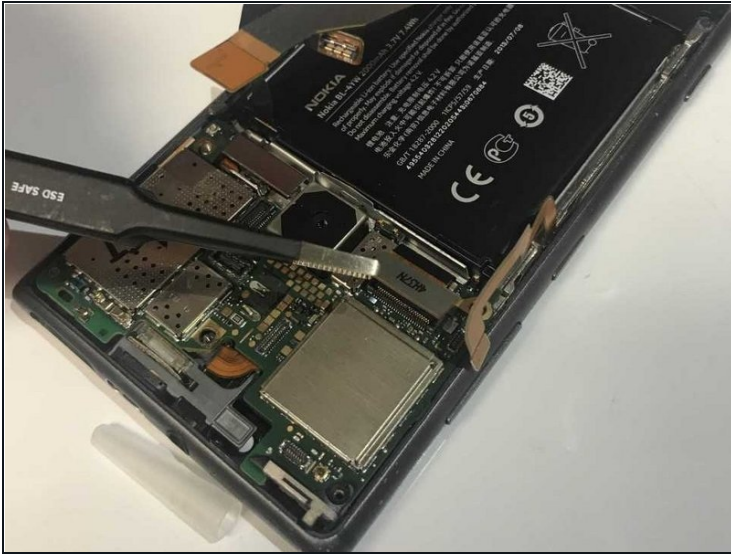
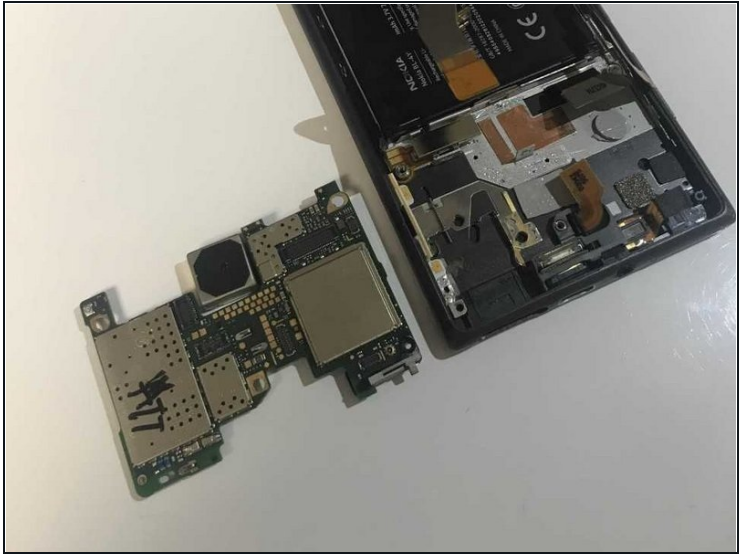
Step 6

- Remove the motherboard by sliding tweezers between it and the back of the screen. Lift up.

To reassemble your device, follow these instructions in reverse order.
