# Sharp Aquos Serie mini SHV31 Volume Rocker Replacement

How to replace a Sharp Aquos Serie mini SHV31 volume rocker.

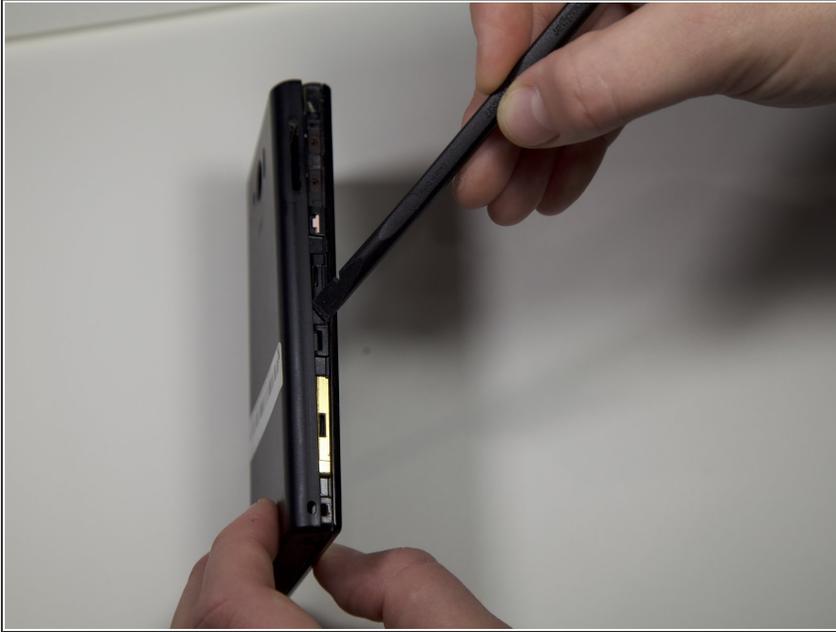
## Step 1 — Volume Rocker

- Begin by using the nylon spudger to pry off the back case.

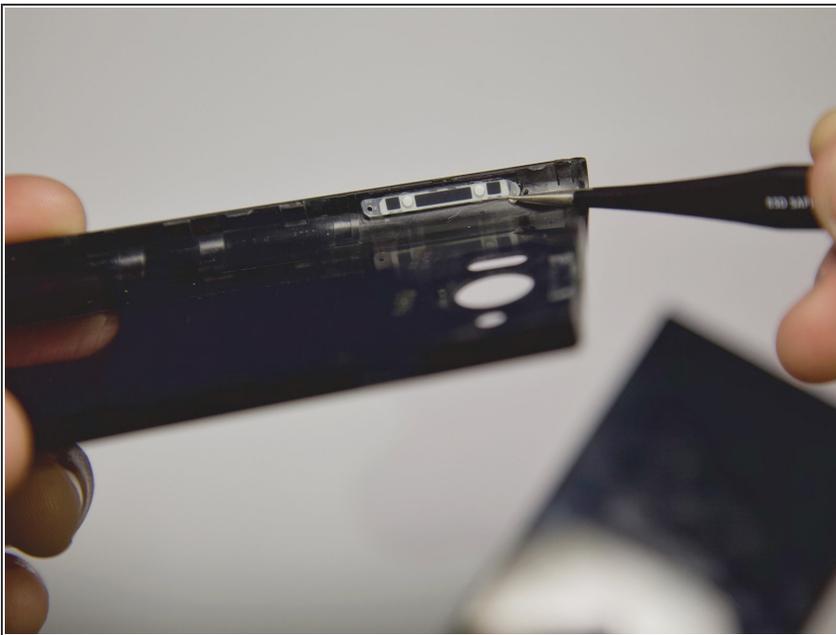
## Step 2

- Use the tweezers to pull the volume rocker from the clips.
