How to repair the GM VATS control module

This repair is for GM vehicles with Vehicle...

Written By: Ed D

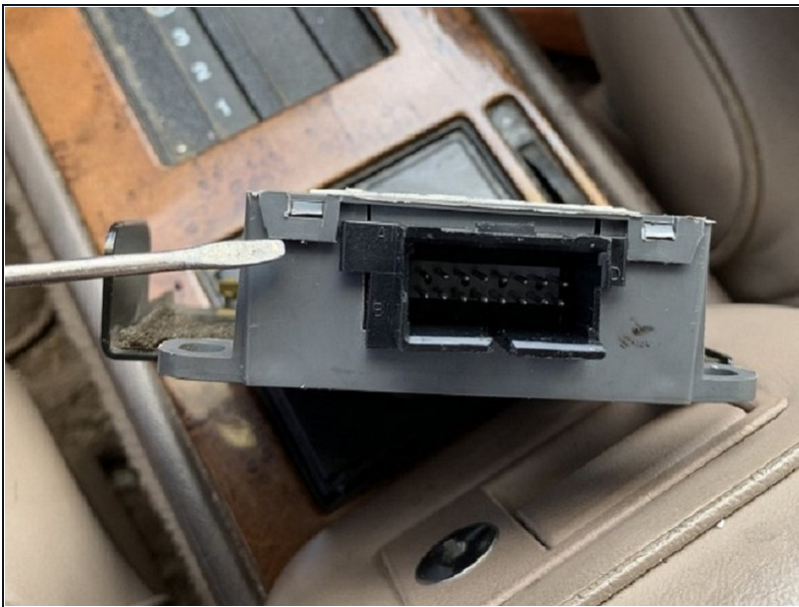
Step 2 — Open the module cover

- Open Module being careful not to break off these two tabs

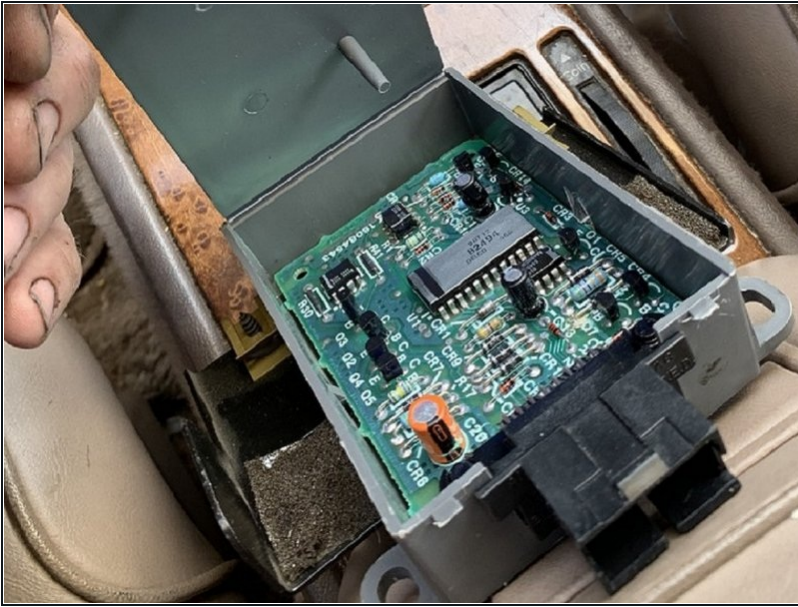
Step 3 — Seperate board from the box

- The board lifts straight up out of the box
