Ryobi P501G Blade Replacement

This guide goes over how to replace the RYOBI P501G power saw's blade.

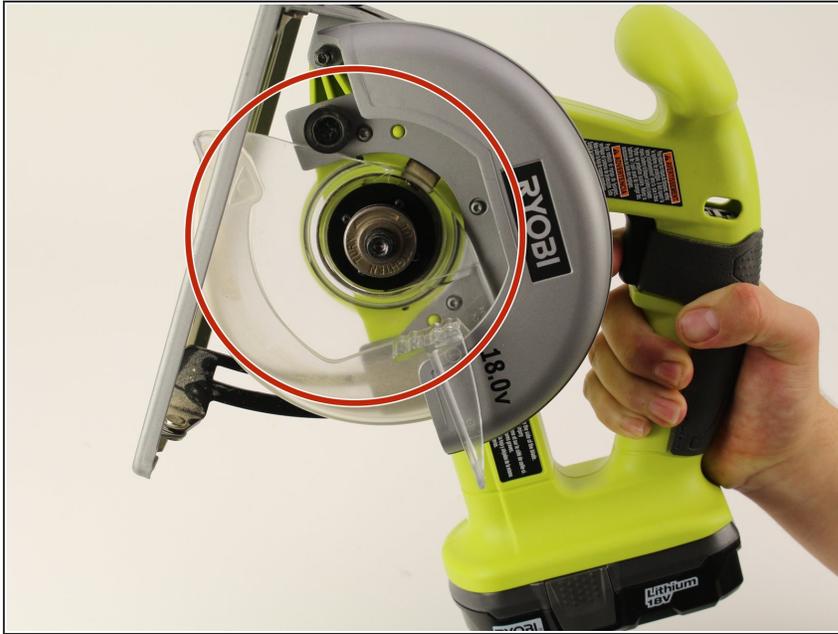
Step 1 — Blade

- Locate the area where the blade is connected to the motor, where the circular covering is on the Ryobi P501G.

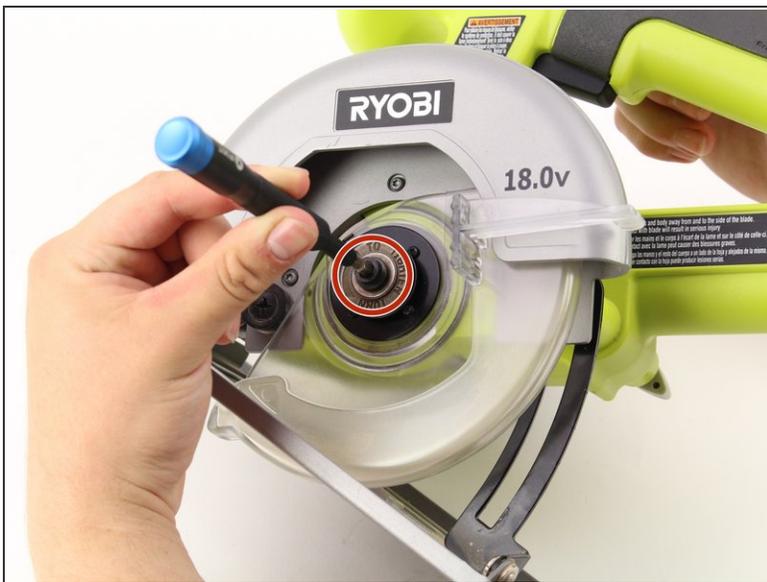
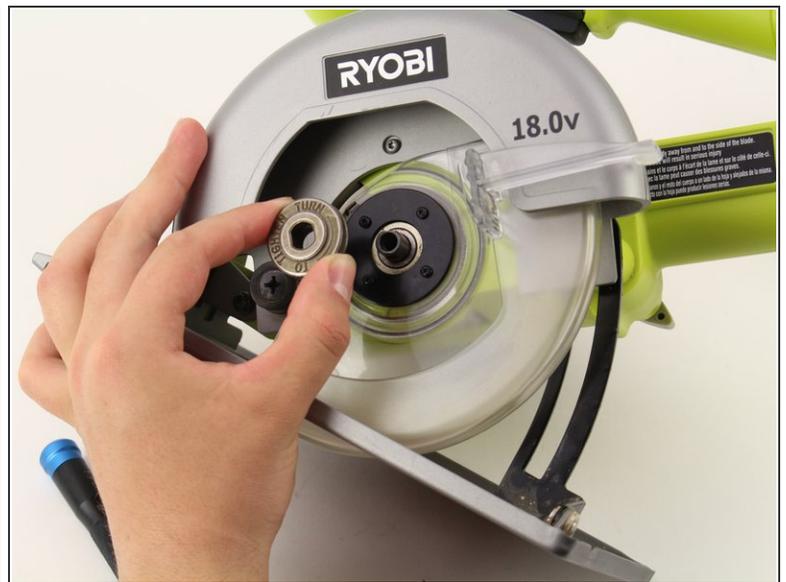
Step 2

- Unscrew clockwise and remove the bearing in the middle, connecting the blade to the motor. This will also allow removal of the blade guard.

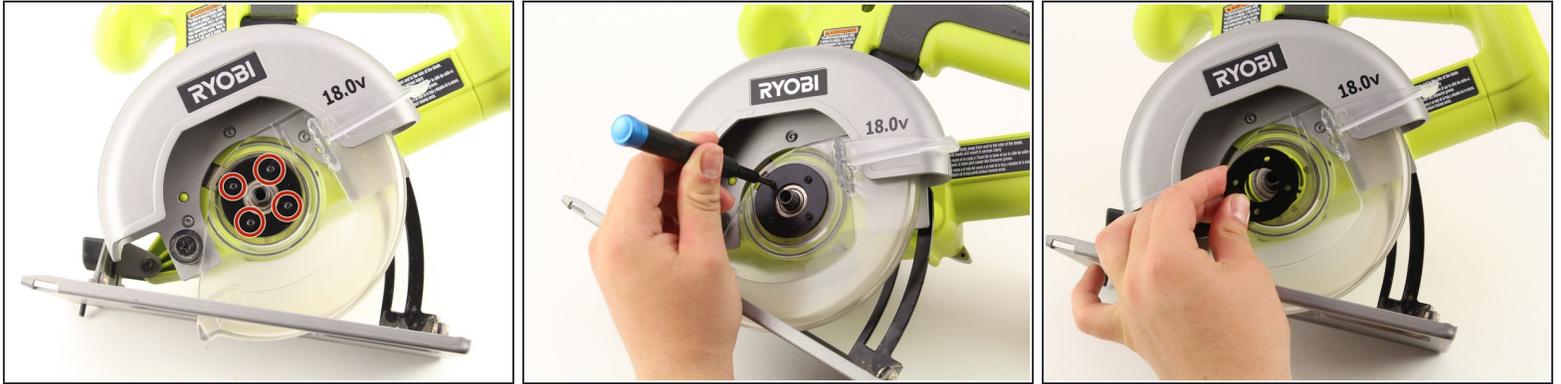
Step 3

- Remove the four black screws holding the black bearing and remove the bearing itself.

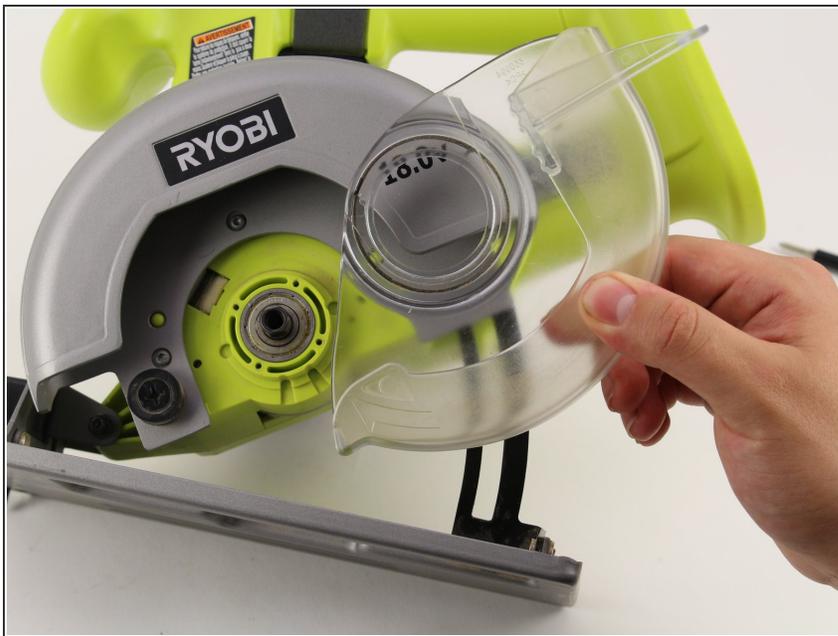
Step 4

- Once the black bearing is off, remove the transparent cover of the blade.
- Once the cover is off, remove the blade.
- Place the new blade with the flat notches lined up with the flat notches on the motor axle.
