Ryobi P271 Magnet Replacement

This guide shows how to replace the magnet in the Ryobi P271.

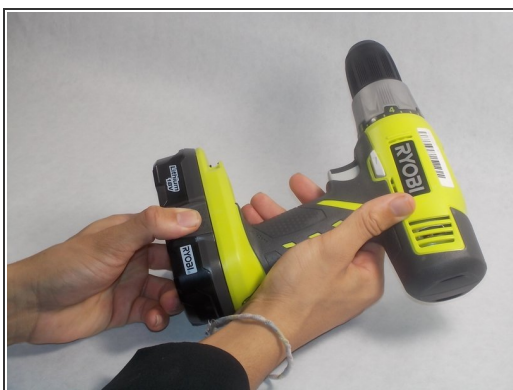
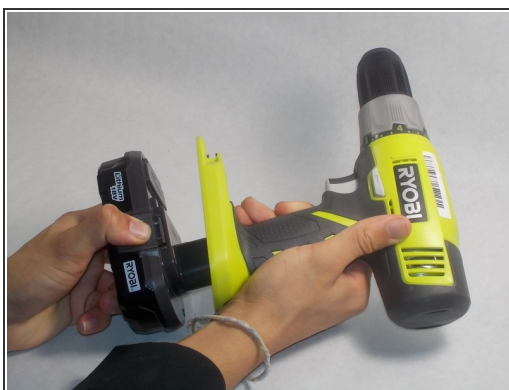
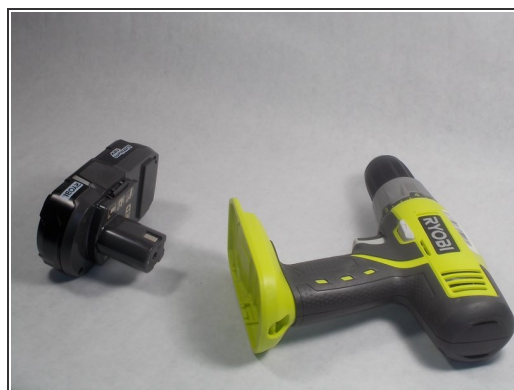
Step 1 — Battery

- Detach the battery unit from the drill body by pressing the battery release buttons on both sides of the unit and pulling outwards.

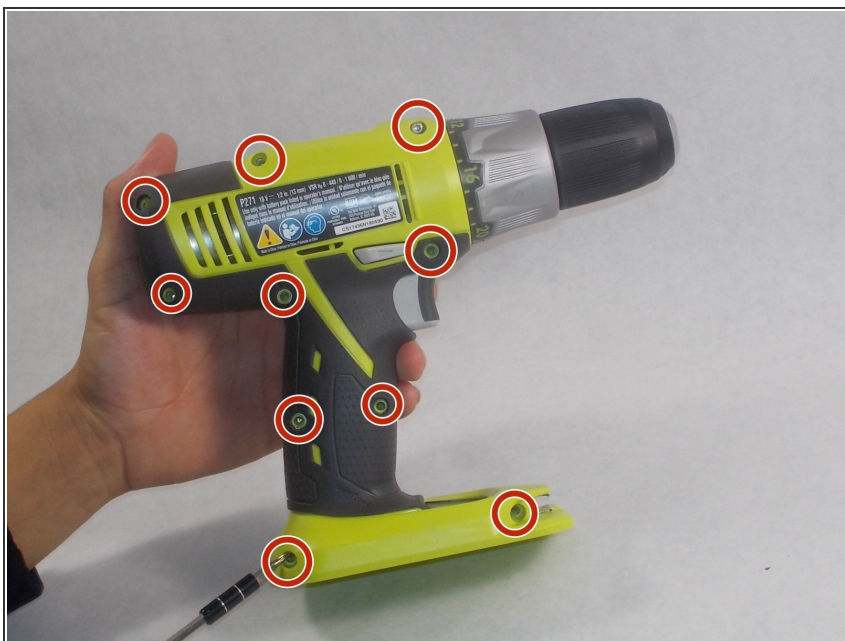
Step 2 — Magnet

- Remove all ten screws from the drill's casing to gain access to the interior.

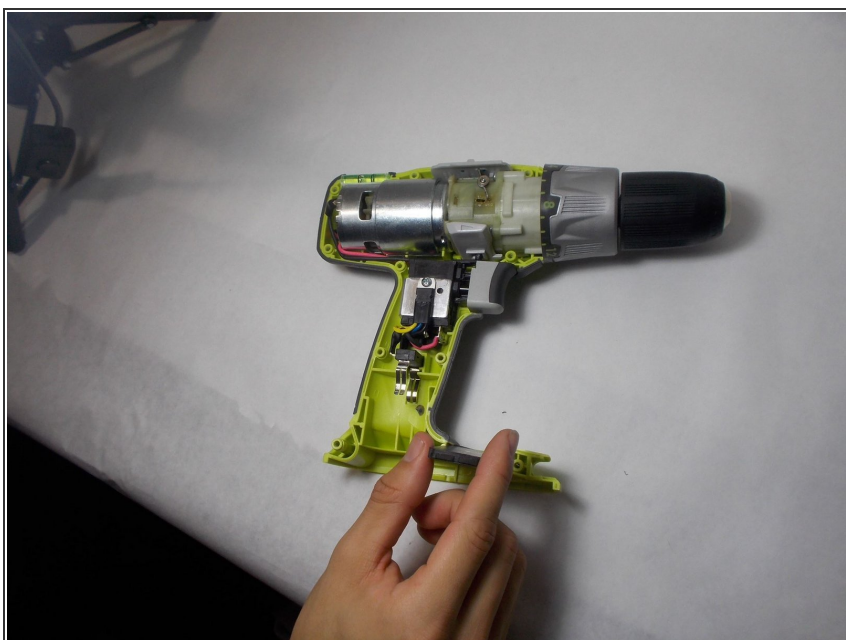
Step 4

- Carefully slide the magnet from its holder.

To reassemble your device, follow these instructions in reverse order.
