Toshiba CB35-3350 Chromebook 2 Bluetooth Chip Replacement

Use this guide to replace your Bluetooth Chip in your Toshiba CB35-3350 Chromebook 2.

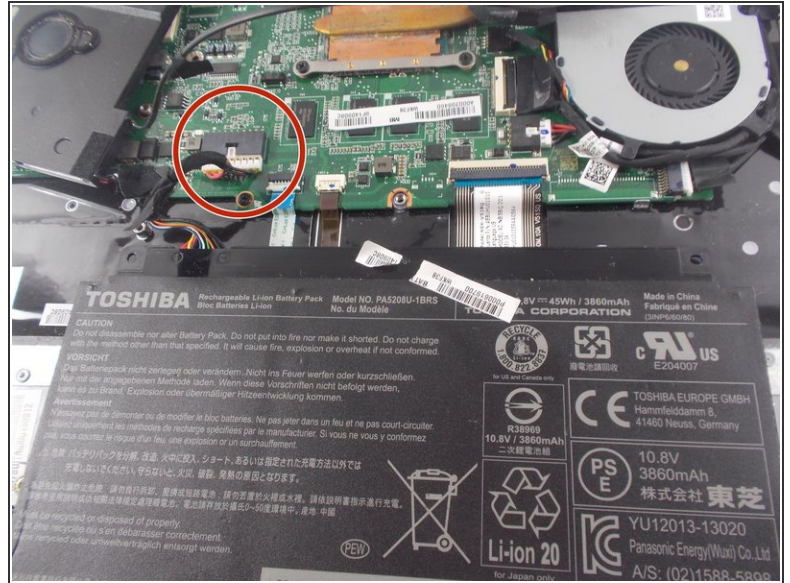
Step 1 — Bluetooth Chip

- Remove the Phillips #0 screws from the back of the laptop.
- Use your hands and an iFixit opening tool to remove the back of the laptop.

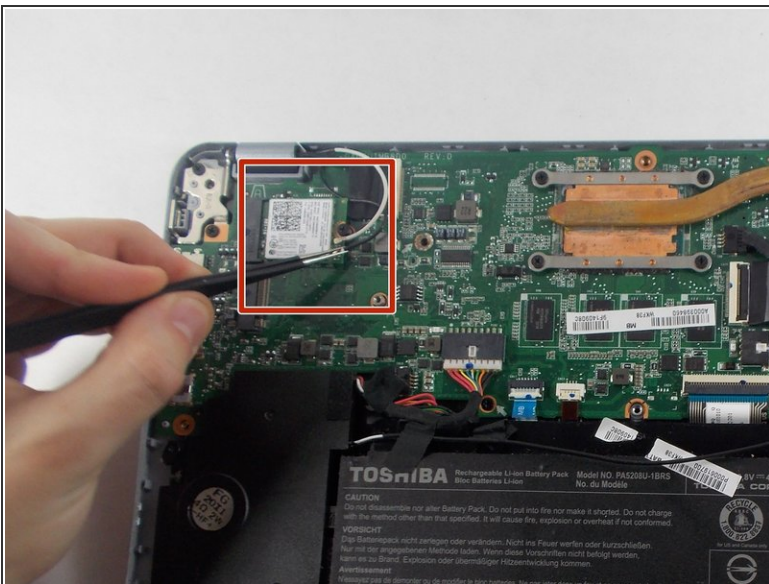
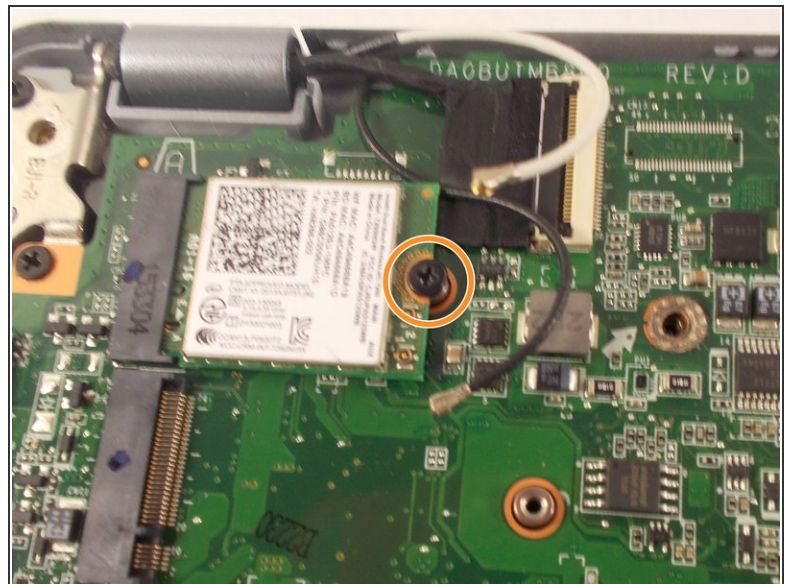
Step 2

- Use a pair of tweezers to remove the wires attached to the Bluetooth chip.
- Remove the screw holding the chip in place.

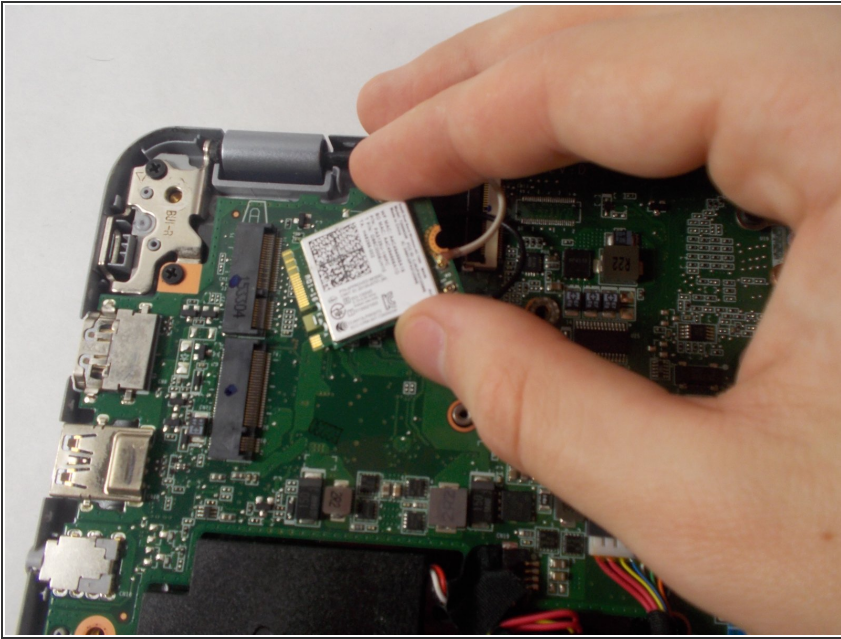
Step 3

- Slide the chip out of its port.

To reassemble your device, follow these instructions in reverse order.
