Toshiba CB35-3350 Chromebook 2 USB Board Replacement

Guide for replacing a USB board/Port in a Toshiba CB35-3350 Chromebook 2.

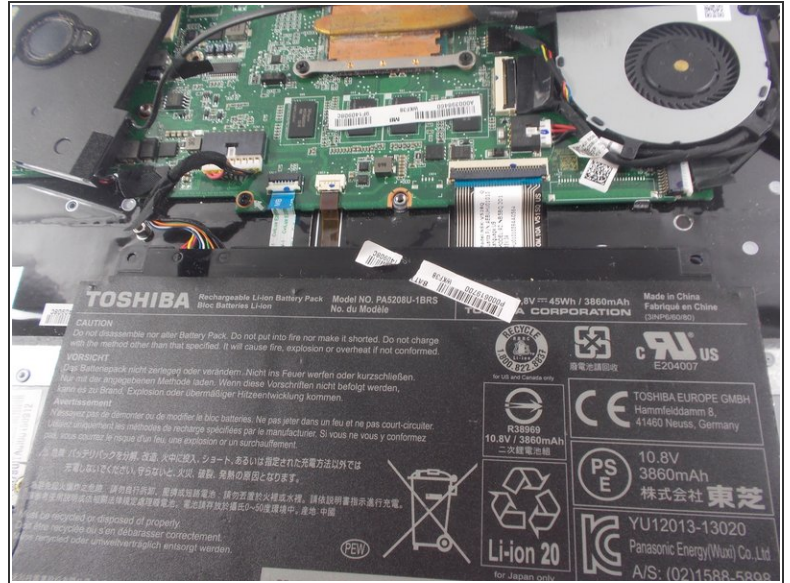
Step 1 — USB Board / USB Port

- Remove the Phillips #0 screws from the back of the laptop.
- Use your hands and an iFixit opening tool to remove the back of the laptop.
