Wahl Lithium Ion Trimmer Metal Razor Arms Replacement

If the blades to your Wahl Lithium Ion Trimmer...

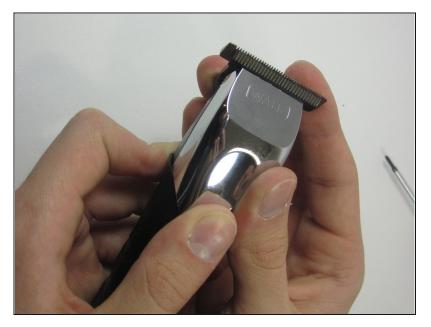
Step 1 — Metal Razor Arms

Examine the razor to identify any broken or jammed blades that require replacement. If any such blades are identified, the whole set must be changed.
