MacBook Pro 15" Retina Display Late 2013 I/O Board Cable Replacement

Replace the I/O board cable in a MacBook Pro 15" Retina Display Late 2013.

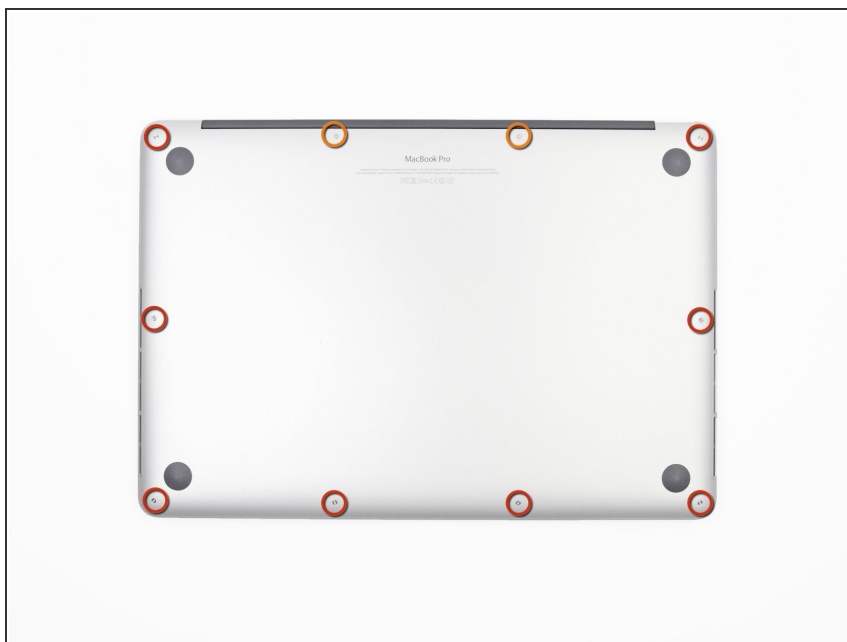
Step 1 — Lower Case

- Remove the following P5 pentalobe screws securing the lower case to the MacBook Pro:
 - Eight 3.0 mm
 - Two 2.3 mm

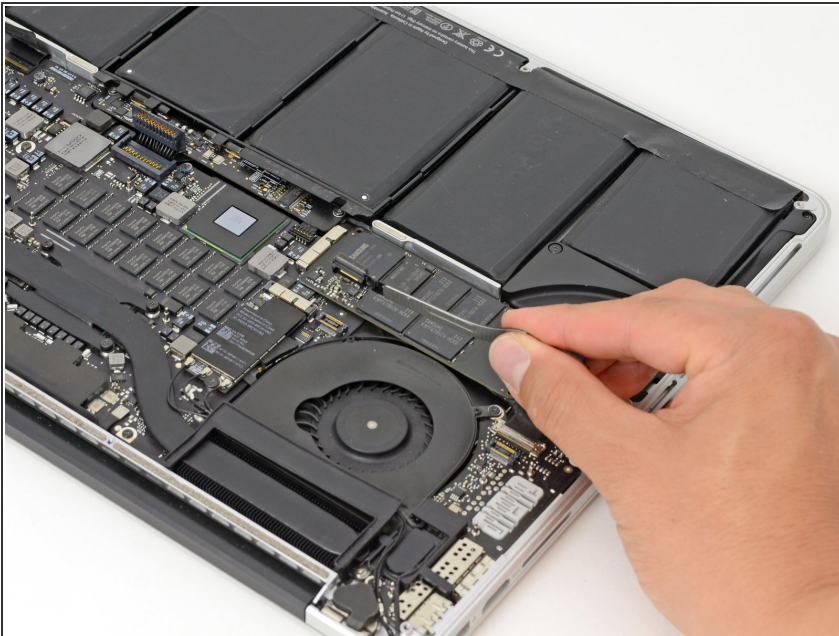
Step 6

- Remove the I/O board cable from the MacBook Pro.
