Sony Ericsson T68i Vibration Motor Replacement

This guide will assist you in removing the vibration motor from your Sony Ericsson T68i.

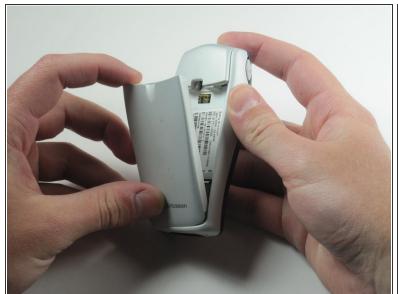
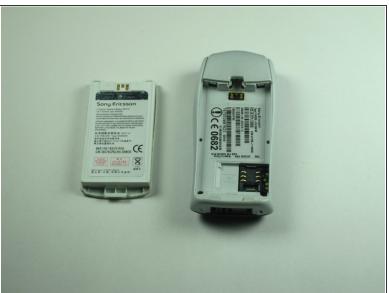
Step 1 — Keypad

Remove the battery from the back.

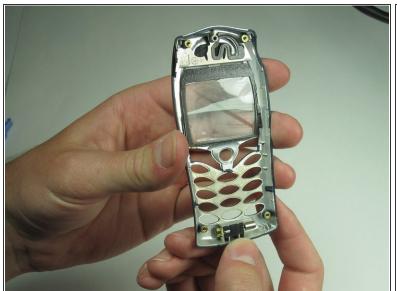
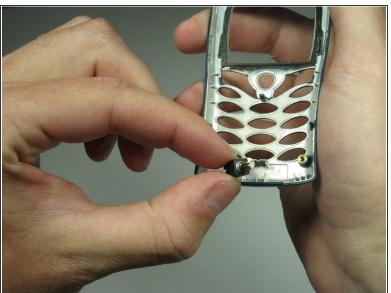
Step 5 — **Vibration Motor**

Remove the vibration motor visible in the front housing.
