# HTC Desire 700 Dual Sim Front Facing Camera Replacement

Written By: Steven Pate

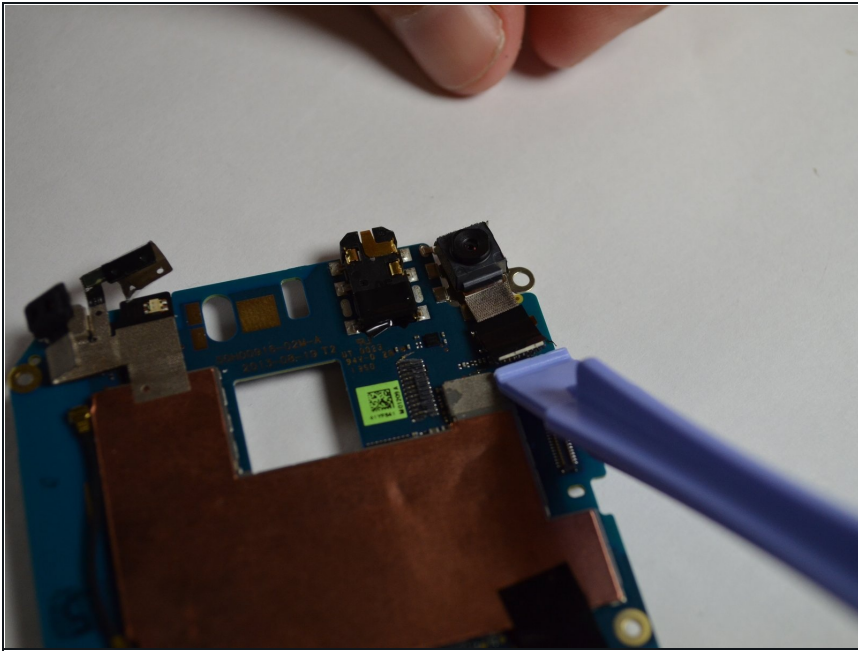
## Step 10 — Removing Camera

- Remove the camera using the plastic opening tool as shown.
