Sony XPERIA Tablet Z Volume Button Replacement

Written By: Martin Luna

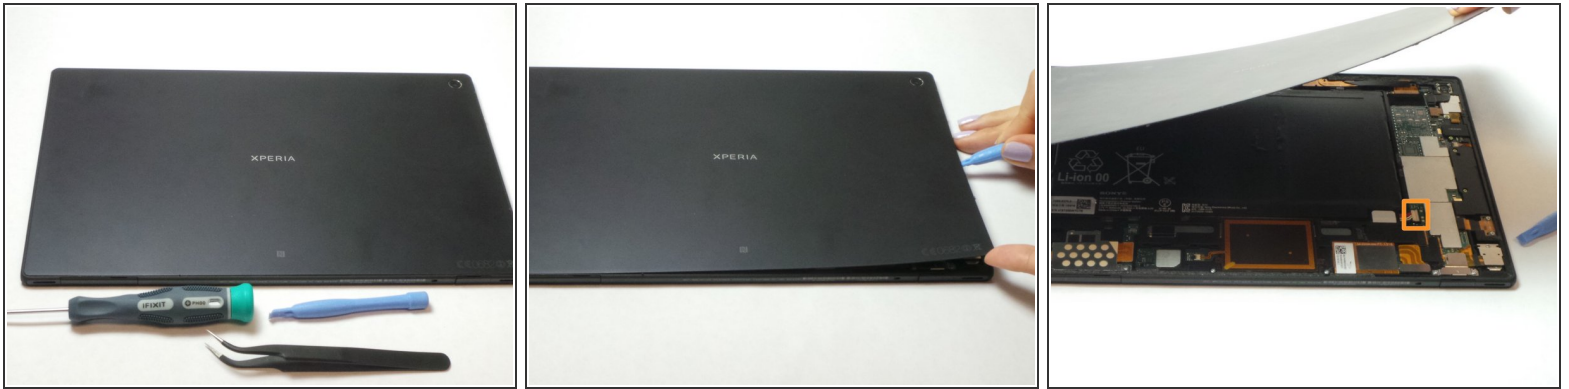
Step 1 — Removing back cover

- Tools you will need is the Phillips #00 precision screwdriver, Plastic Opening Tools, and tweezers.
- Insert plastic opening tool in the corner of device and slide along edges to separate adhesive.
- Remove cover
- Disconnect battery, to avoid electric shock, by pulling up on the white plastic as shown by the orange box.

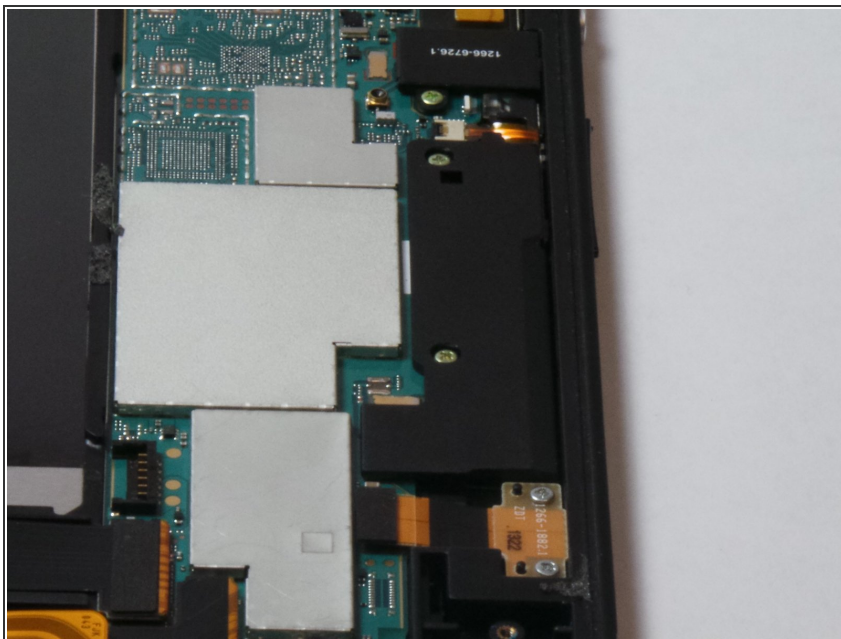
Step 2 — Locate the Volume module

- Locate the volume module.
- Remove both screws using the Philips screwdriver.

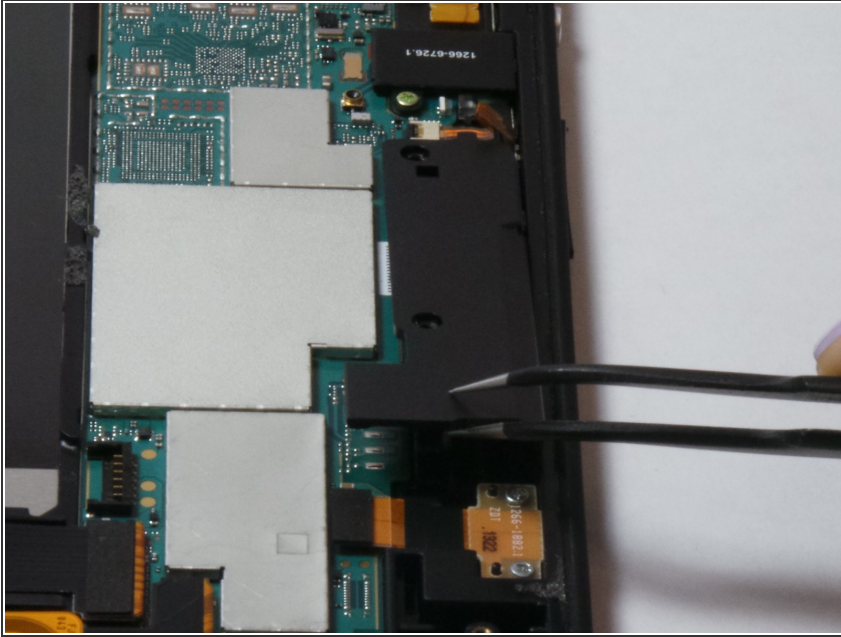
Step 3 — Lift out of Place

- Once both screws are removed grab the tweezers.
- Then lift up on the module.

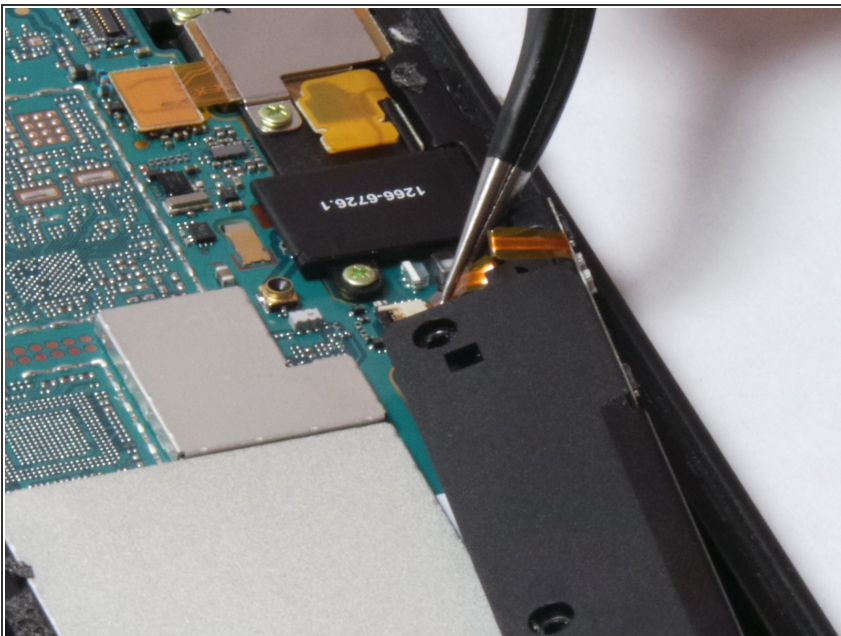
Step 4 — Removing the Electrical tape

- Find the electrical tape connecting the module to the motherboard
- Carefully pull out the electrical tape horizontally and remove the volume module from the device.
