# Nokia Lumia 920 Back panel Replacement

Replace the back panel if: cracked, charging port is broken, panel is cracked.

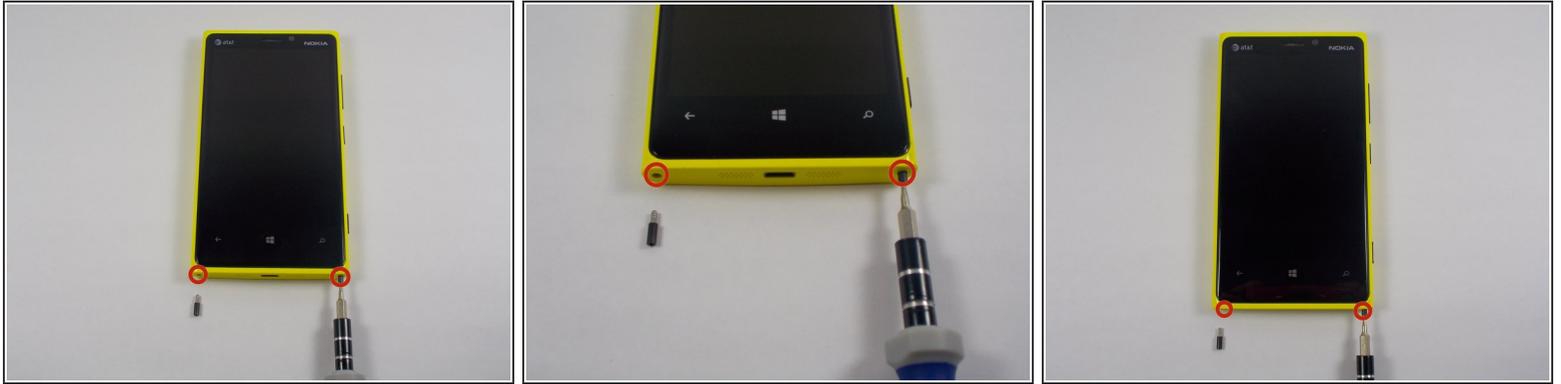
## Step 1 — Remove the Bottom Screws

- Use the T5 screwdriver to remove the two 8.6mm long screws, located at the bottom of the phone. (Head size is 2.5mm)
