Minolta Maxxum STsi Clock Battery Replacement

Written By: Conner Lawston

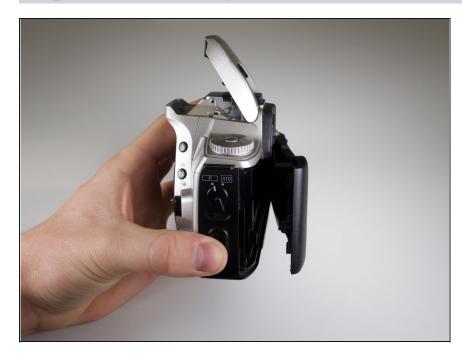
Step 1 — Clock Battery

Press up firmly on the backcover release on the right side of the camera to release the back panel.

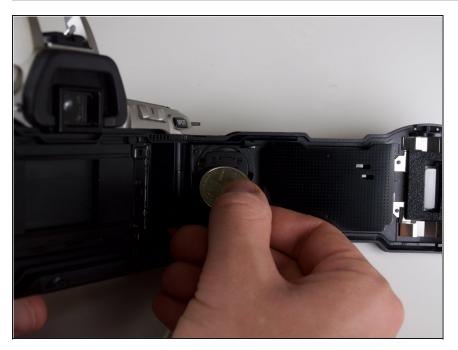
Step 2

Use a coin to twist open the battery compartment (twist counterclockwise).

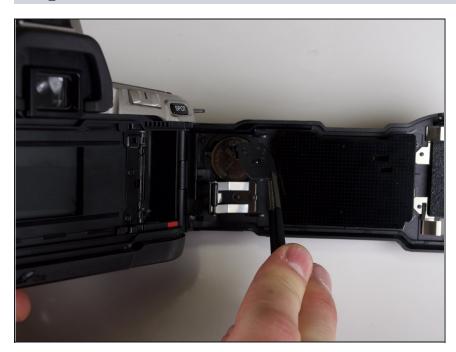
Step 3

• Use <u>tweezers</u> to lift off the battery compartment cover.

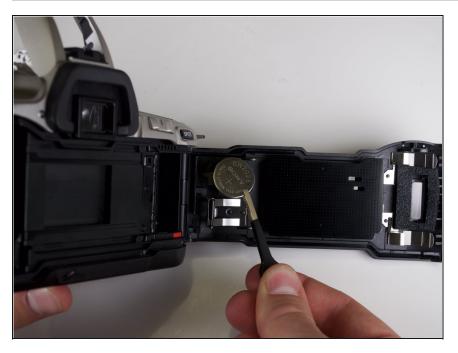
Step 4

Use tweezers to take out the old clock battery and replace it with a new one.
