# Garmin Nuvi 1490T Front Frame Panel Replacement

Replace damaged frame to have your GPS look new again.

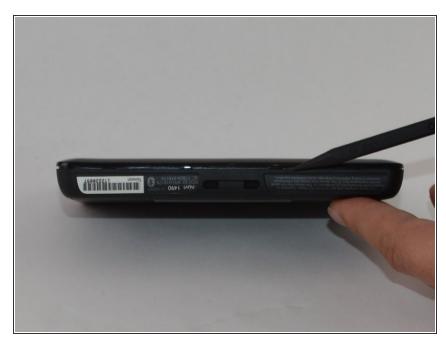
#### **Step 1 — Front Frame Panel**

- Power off your GPS before moving on.
- Locate the crevice that separates the frame from the body.

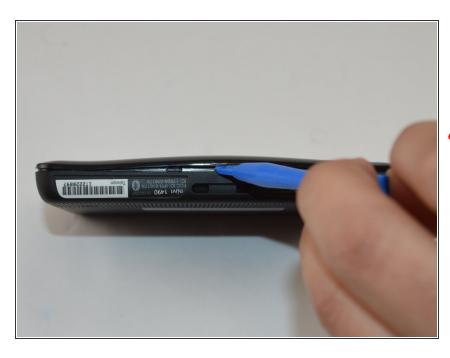
#### Step 2

- Carefully insert the plastic prying tool into the crevice to separate the frame from the body.
- Applying excessive force can lead to a damaged or scratched display screen.

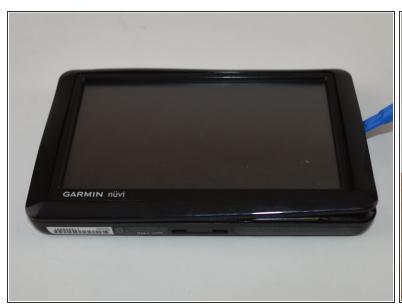
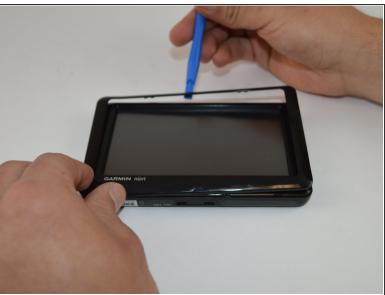
## Step 3

Slide the plastic prying tool around the perimeter to completely remove the frame.

To reassemble your device, follow these instructions in reverse order.
