# HP Pavilion ze4530US CD Rom Replacement

Replace a CD Rom that is not capable of reading discs.

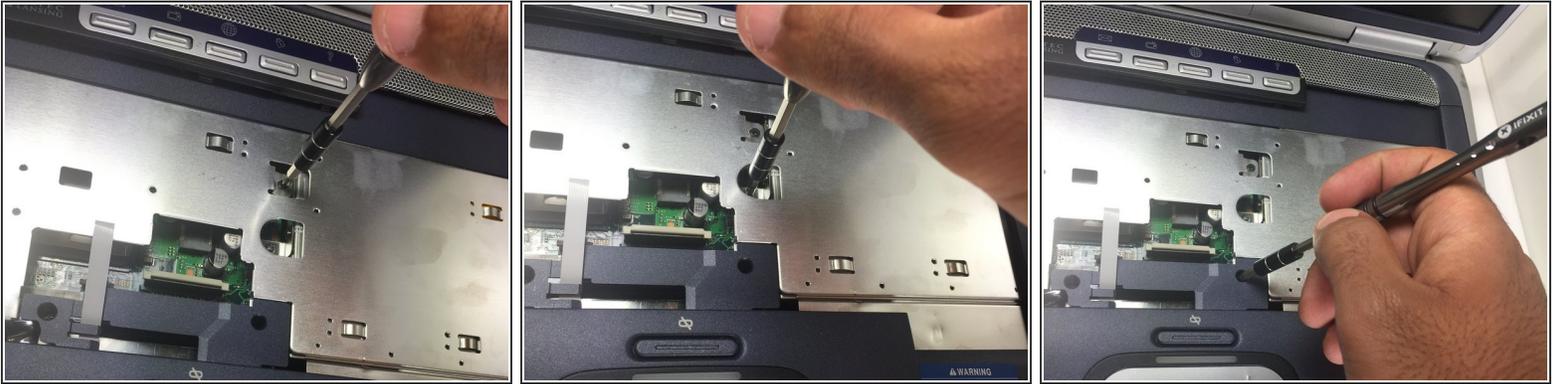
## Step 1 — CD Rom

- Unscrew three screws from under the keyboard. The keyboard must be removed for this process.

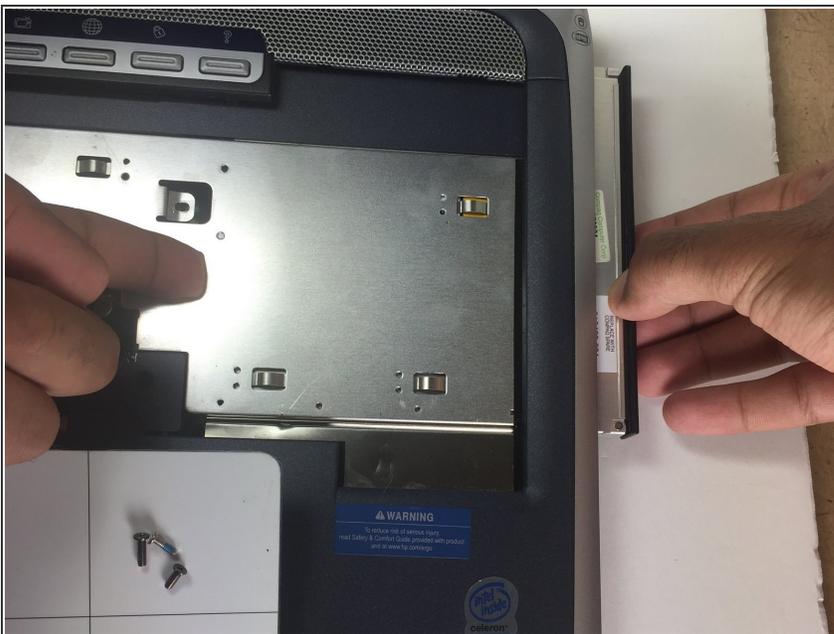
## Step 2

- After the screws have been removed, use one finger to push the CD Rom out while the other hand is simultaneously pulling the CD Rom out.

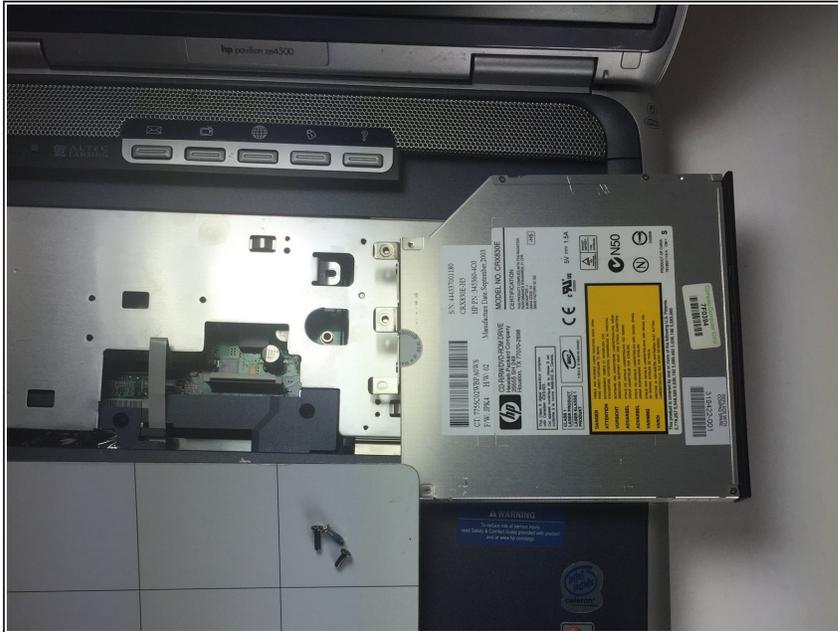
## Step 3

- The CD Rom has been successfully taken out.
