# Garmin Nuvi 2589LMT Motherboard Replacement

If your device is not turning on, you may need to replace your motherboard. Use this guide to replace a defective motherboard in your Garmin NUVI 2589LMT device. This replacement guide requires more time than replacing the other components in your GPS, since this guide involves soldering.

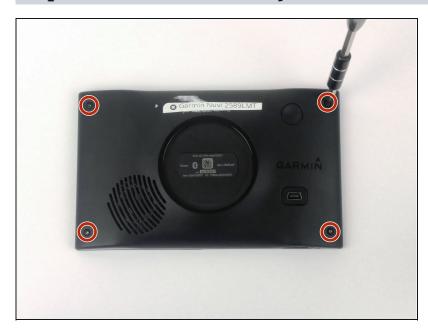
#### **Step 1 — Back Panel Assembly**

Using the T5 Torx Screwdriver, remove all 4 of the 5.7mm screws from the back of the device.

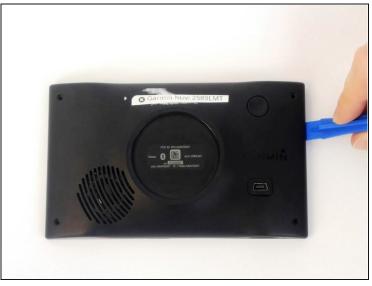
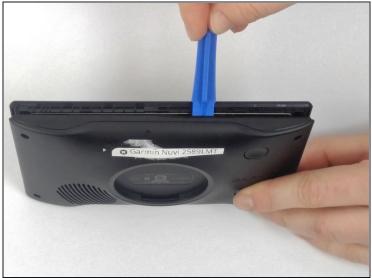
- Using the plastic opening tools, pry the shorter sides of the device apart.
- Once a gap has formed at the top of the device, insert the opening tool into the gap and slide it along the top of the device. Repeat for the bottom edge of the device to separate the LCD screen from the back.

⚠ Do not disconnect or tear the ribbon wiring, located at the bottom of the motherboard, when removing the back of the device.

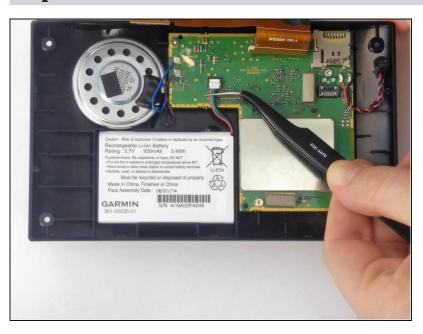
#### Step 3 — Motherboard

Using the angled tweezers, grip the red, black, and green wires connecting the battery to the motherboard, then gently lift away from the motherboard.

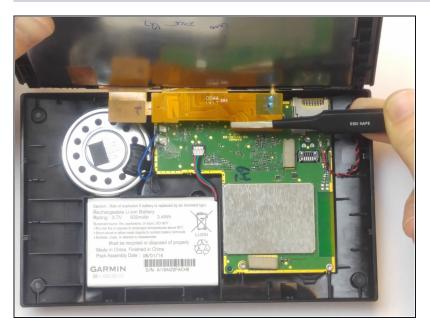
Using the tweezers, gently pull the ribbon wiring near where it connects to the motherboard to disconnect it from the motherboard.

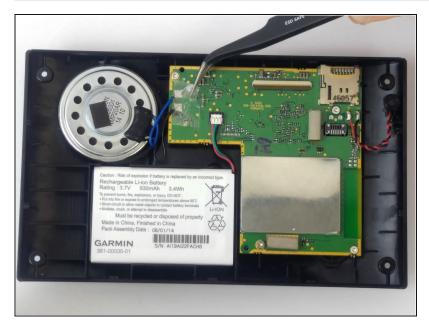
## Step 5

Using tweezers, remove the tape covering the speaker connection to the motherboard.

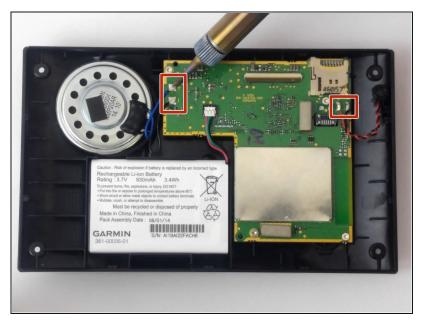
- Using a soldering iron, desolder all connections to the motherboard.
- (i) Learn how to solder and desolder here.

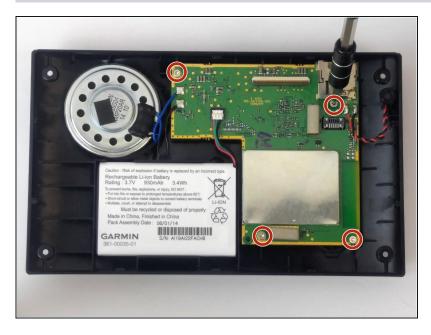
## Step 7

Using the T5 Torx Screwdriver, remove all 4 of the 4.0 mm screws from the motherboard.

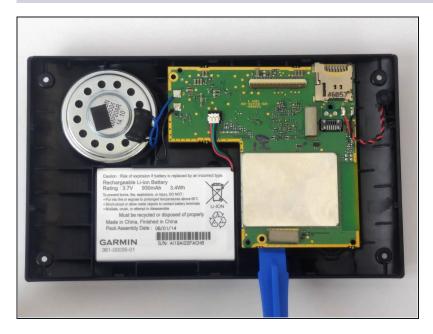
Using the plastic opening tools gently pry the motherboard away from the case.
